# Access Compliance Report

## Public Rights-of-Way

### (Curb Ramps)

Intersection ID: 51519	Main Street: E_JOHN_BELK_RA	Cross Street: SOUTH_BV	Location: NW
ADA ID: BCA49456D01B	Ramp Type: Perp	Initial Pass/Fail: Fail	Overall Compliance: No
Severity Score: 12.5			
Codes/Mitigation Info/Possible Solution		Field Measurements/Component Compliance

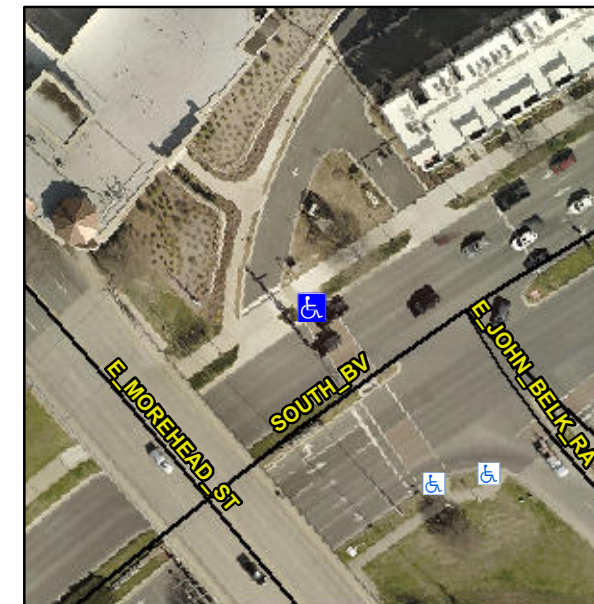
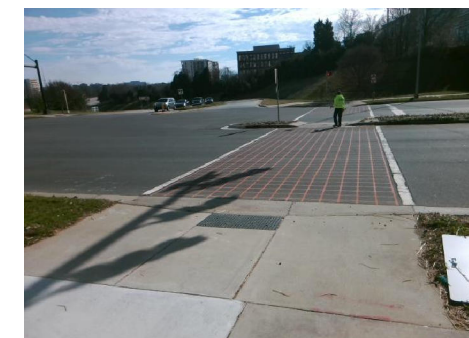
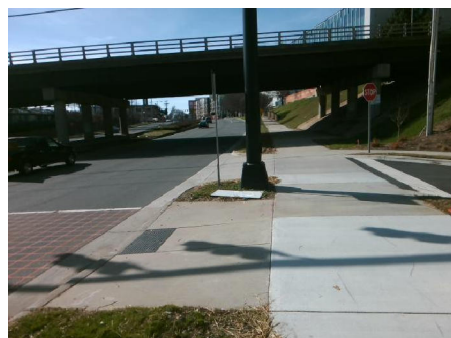
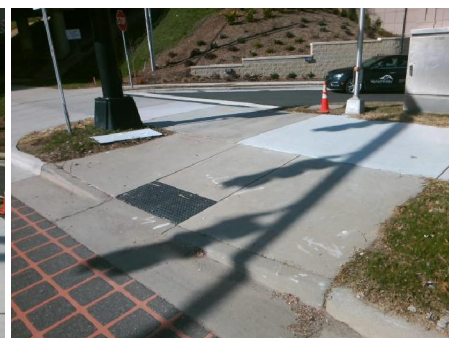
**Not Found, R304.2.2**

Compliance	Description	Data	Compliance	Description	Data
N/A	Ramp Length (in)	95.5	No	Ramp Slope (%)	8.6
Yes	Ramp Width (in)	48.0	Yes	Ramp XSlope (%)	0.3
N/A	Flare Type LT	N/A	N/A	Flare Type RT	N/A
N/A	Flare Slope LT (%)	N/A	N/A	Flare Slope RT (%)	N/A
N/A	Flare Traversable LT?	N/A	N/A	Flare Traversable RT?	N/A
N/A	Landing Length (in)	N/A	N/A	DWS Provided?	N/A
N/A	Landing Width (in)	N/A	N/A	DWS Contrast?	N/A
N/A	Landing Slope (%)	N/A	N/A	DWS Length (in)	N/A
N/A	Landing X Slope (%)	N/A	N/A	DWS Full Width?	N/A
N/A	Landing Curb? (Y/N)	N/A	N/A	DWS Offset (in)	N/A
N/A	Shared Landing?	N/A			
N/A	Gutter Ponding?	N/A	N/A	Gutter Slope (%)	N/A
N/A	Gutter Lip Ht (in)	N/A	N/A	Gutter X Slope (%)	N/A
N/A	Painted X Walk1?	Yes	N/A	Painted X Walk2?	N/A
	X Walk 1 Direction	To SE		X Walk 2 Direction	N/A
N/A	X Walk 1 Width (in)	185.0	N/A	X Walk 2 Width (in)	N/A
	X Walk 1 Slope (%)	3.2		X Walk 2 Slope (%)	N/A
	X Walk 1 X Slope (%)	0.2		X Walk 2 X Slope (%)	N/A

N/A	Ramp inside XWalk1?	Yes	N/A	Ramp inside XWalk2?	N/A
	Road Slope (%)	N/A	N/A	Clear Space?	N/A
	Road X Slope (%)	N/A	N/A	Clear Space to XWalk (in)	N/A
N/A	Any Obstructions?	N/A	N/A	Storm Grate/Utility Hazard?	N/A
	Obstruction Type			Storm Grate/Utility Type	
		N/A			N/A
			Yes	Surface Condition? (G/P)	Good

**Remove & Replace Entire Ramp.**
