Access Compliance Report

Public Rights-of-Way

(Curb Ramps)

Intersection ID: 46032	Main Street: DOMINION_VILLAGE_DR	Cross Street: MILLSTREAM_RIDGE_DR	Location: W
ADA ID: BCA968C14AC2	Ramp Type: PerpDiag	Initial Pass/Fail: Fail	Overall Compliance: No
Severity Score: 21.25			
Codes/Mitigation Info/Possible Solution		Field Measurements/Component Compliance

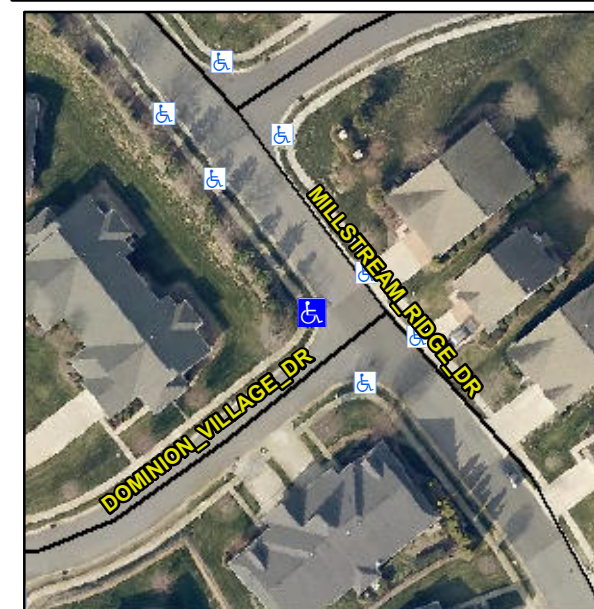
Not Found, R304.5.1, R304.5.3

Compliance	Description	Data	Compliance	Description	Data
N/A	Ramp Length (in)	49.0	Yes	Ramp Slope (%)	5.3
No	Ramp Width (in)	40.0	No	Ramp XSlope (%)	5.2
N/A	Flare Type LT	N/A	N/A	Flare Type RT	N/A
N/A	Flare Slope LT (%)	N/A	N/A	Flare Slope RT (%)	N/A
N/A	Flare Traversable LT?	N/A	N/A	Flare Traversable RT?	N/A
N/A	Landing Length (in)	N/A	N/A	DWS Provided?	N/A
N/A	Landing Width (in)	N/A	N/A	DWS Contrast?	N/A
N/A	Landing Slope (%)	N/A	N/A	DWS Length (in)	N/A
N/A	Landing X Slope (%)	N/A	N/A	DWS Full Width?	N/A
N/A	Landing Curb? (Y/N)	N/A	N/A	DWS Offset (in)	N/A
N/A	Shared Landing?	N/A			
N/A	Gutter Ponding?	N/A	N/A	Gutter Slope (%)	N/A
N/A	Gutter Lip Ht (in)	N/A	N/A	Gutter X Slope (%)	N/A
N/A	Painted X Walk1?	No	N/A	Painted X Walk2?	No
	X Walk 1 Direction	To SE		X Walk 2 Direction	To NE
N/A	X Walk 1 Width (in)	N/A	N/A	X Walk 2 Width (in)	N/A
	X Walk 1 Slope (%)	1.1		X Walk 2 Slope (%)	6.4
	X Walk 1 X Slope (%)	6.9		X Walk 2 X Slope (%)	1.7

N/A	Ramp inside XWalk1?	N/A	N/A	Ramp inside XWalk2?	N/A
	Road Slope (%)	5.0	N/A	Clear Space?	N/A
	Road X Slope (%)	2.0	N/A	Clear Space to XWalk (in)	N/A
N/A	Any Obstructions?	N/A	N/A	Storm Grate/Utility Hazard?	N/A
	Obstruction Type			Storm Grate/Utility Type	
		N/A			N/A
			Yes	Surface Condition? (G/P)	Good

Remove & Replace Curb Ramp With Two New Directional Ramps or Equivalent.
