Access Compliance Report

Public Rights-of-Way

(Curb Ramps)

Intersection ID: 14994	Main Street: OLD_MEADOW_RD	Cross Street: SHACKLEFORD_TR	Location: NE
ADA ID: BCB14E250876	Ramp Type: PerpDiag	Initial Pass/Fail: Fail	Overall Compliance: No
		Severity Score: 12.5

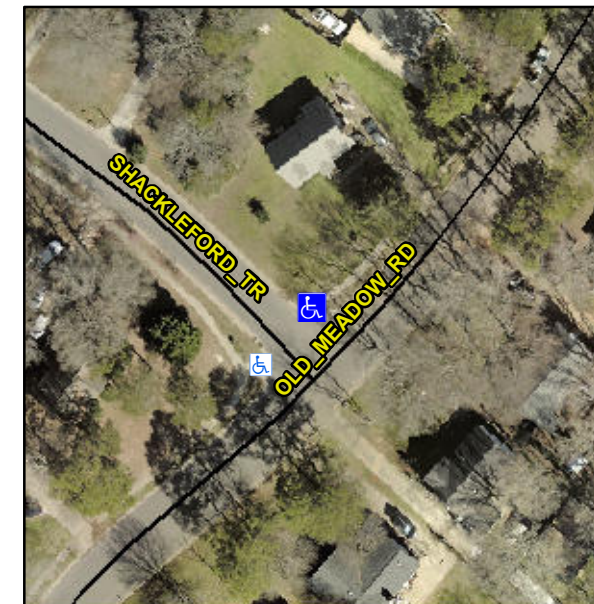
Not Found, R304.2.2

Compliance	Description	Data	Compliance	Description	Data
N/A	Ramp Length (in)	60.0	No	Ramp Slope (%)	8.7
Yes	Ramp Width (in)	48.0	Yes	Ramp XSlope (%)	1.3
N/A	Flare Type LT	N/A	N/A	Flare Type RT	N/A
N/A	Flare Slope LT (%)	N/A	N/A	Flare Slope RT (%)	N/A
N/A	Flare Traversable LT?	N/A	N/A	Flare Traversable RT?	N/A
N/A	Landing Length (in)	N/A	N/A	DWS Provided?	N/A
N/A	Landing Width (in)	N/A	N/A	DWS Contrast?	N/A
N/A	Landing Slope (%)	N/A	N/A	DWS Length (in)	N/A
N/A	Landing X Slope (%)	N/A	N/A	DWS Full Width?	N/A
N/A	Landing Curb? (Y/N)	N/A	N/A	DWS Offset (in)	N/A
N/A	Shared Landing?	N/A			
N/A	Gutter Ponding?	N/A	N/A	Gutter Slope (%)	N/A
N/A	Gutter Lip Ht (in)	N/A	N/A	Gutter X Slope (%)	N/A
N/A	Painted X Walk1?	No	N/A	Painted X Walk2?	No
	X Walk 1 Direction	To SW		X Walk 2 Direction	To SE
N/A	X Walk 1 Width (in)	N/A	N/A	X Walk 2 Width (in)	N/A
	X Walk 1 Slope (%)	4.5		X Walk 2 Slope (%)	4.2
	X Walk 1 X Slope (%)	2.2		X Walk 2 X Slope (%)	2.0

N/A	Ramp inside XWalk1?	N/A	N/A	Ramp inside XWalk2?	N/A
	Road Slope (%)	0.6	N/A	Clear Space?	N/A
	Road X Slope (%)	6.1	N/A	Clear Space to XWalk (in)	N/A
N/A	Any Obstructions?	N/A	N/A	Storm Grate/Utility Hazard?	N/A
	Obstruction Type			Storm Grate/Utility Type	
		N/A			N/A
			Yes	Surface Condition? (G/P)	Good

Remove & Replace Curb Ramp With Two New Directional Ramps or Equivalent.

Total Cost: \$ 3200.00
