Access Compliance Report

Public Rights-of-Way

(Curb Ramps)

Intersection ID: 19960	Main Street: ARCHDALE_DR	Cross Street: NETHERWOOD_DR	Location: SW
ADA ID: BCB61F6EC2E3	Ramp Type: PerpDiag	Initial Pass/Fail: Fail	Overall Compliance: No
Severity Score: 22.5			
Codes/Mitigation Info/Possible Solution		Field Measurements/Component Compliance

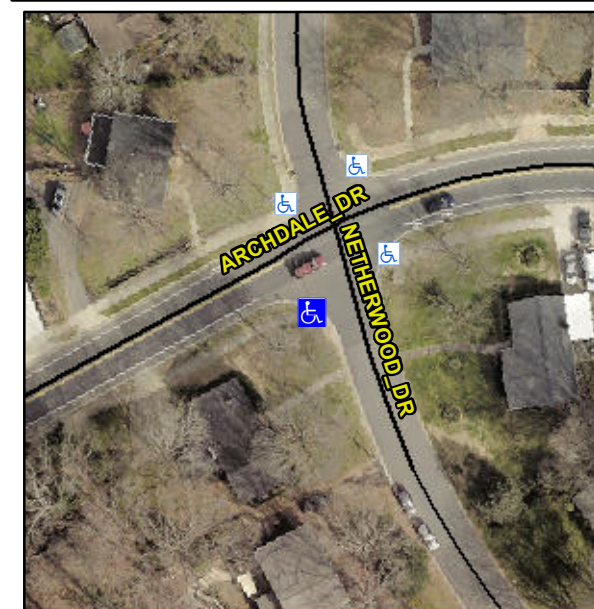
Not Found, R304.5.1, R304.2.2, R304.5.3

Compliance	Description	Data	Compliance	Description	Data
N/A	Ramp Length (in)	82.0	No	Ramp Slope (%)	8.6
No	Ramp Width (in)	44.0	No	Ramp XSlope (%)	2.1
N/A	Flare Type LT	N/A	N/A	Flare Type RT	N/A
N/A	Flare Slope LT (%)	N/A	N/A	Flare Slope RT (%)	N/A
N/A	Flare Traversable LT?	N/A	N/A	Flare Traversable RT?	N/A
N/A	Landing Length (in)	N/A	N/A	DWS Provided?	N/A
N/A	Landing Width (in)	N/A	N/A	DWS Contrast?	N/A
N/A	Landing Slope (%)	N/A	N/A	DWS Length (in)	N/A
N/A	Landing X Slope (%)	N/A	N/A	DWS Full Width?	N/A
N/A	Landing Curb? (Y/N)	N/A	N/A	DWS Offset (in)	N/A
N/A	Shared Landing?	N/A			
N/A	Gutter Ponding?	N/A	N/A	Gutter Slope (%)	N/A
N/A	Gutter Lip Ht (in)	N/A	N/A	Gutter X Slope (%)	N/A
N/A	Painted X Walk1?	No	N/A	Painted X Walk2?	No
	X Walk 1 Direction	To NE		X Walk 2 Direction	To N
N/A	X Walk 1 Width (in)	N/A	N/A	X Walk 2 Width (in)	N/A
	X Walk 1 Slope (%)	7.1		X Walk 2 Slope (%)	3.3
	X Walk 1 X Slope (%)	3.3		X Walk 2 X Slope (%)	6.6

N/A	Ramp inside XWalk1?	N/A	N/A	Ramp inside XWalk2?	N/A
	Road Slope (%)	2.9	N/A	Clear Space?	N/A
	Road X Slope (%)	7.6	N/A	Clear Space to XWalk (in)	N/A
N/A	Any Obstructions?	N/A	N/A	Storm Grate/Utility Hazard?	N/A
	Obstruction Type			Storm Grate/Utility Type	
		N/A			N/A
			Yes	Surface Condition? (G/P)	Good

Possible Solutions:

Remove & Replace Curb Ramp With Two New Directional Ramps or Equivalent.
