Access Compliance Report

Public Rights-of-Way

(Curb Ramps)

Intersection ID: 51353	Main Street: MCCULLOUGH_DR	Cross Street: BRENTMOOR_DR	Location: NW
ADA ID: BCC03A7A8449	Ramp Type: PerpDiag	Initial Pass/Fail: Pass	Overall Compliance: No
Severity Score: 7.5			
Codes/Mitigation Info/Possible Solution		Field Measurements/Component Compliance

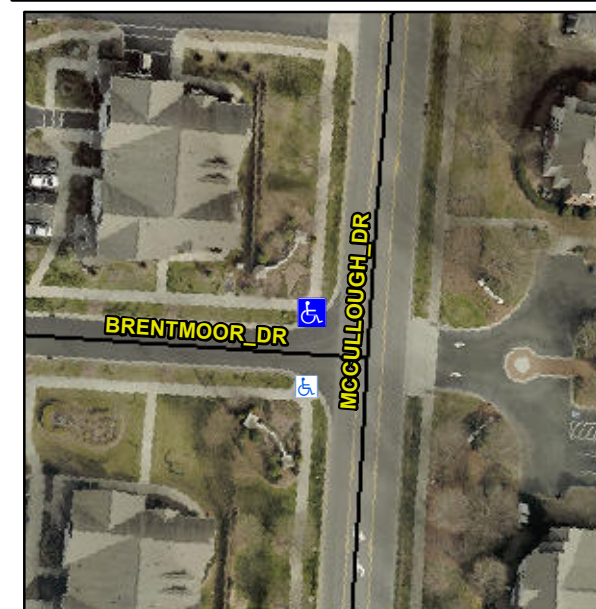
Not Found, R304.2.2-Perp, R304.3.2-Para, R304.5.3, R302.7.2

Compliance	Description	Data	Compliance	Description	Data
N/A	Ramp Length (in)	64.0	Yes	Ramp Slope (%)	6.5
Yes	Ramp Width (in)	48.0	Yes	Ramp XSlope (%)	1.9
N/A	Flare Type LT	Sloped	N/A	Flare Type RT	N/A
N/A	Flare Slope LT (%)	0.4	N/A	Flare Slope RT (%)	8.9
N/A	Flare Traversable LT?	No	N/A	Flare Traversable RT?	No
Yes	Landing Length (in)	65.0	Yes	DWS Provided?	Yes
Yes	Landing Width (in)	50.0	Yes	DWS Contrast?	Yes
No	Landing Slope (%)	2.2	Yes	DWS Length (in)	24.5
No	Landing X Slope (%)	2.3	Yes	DWS Full Width?	Yes
N/A	Landing Curb? (Y/N)	No	Yes	DWS Offset (in)	1.3
N/A	Shared Landing?	No			
Yes	Gutter Ponding?	No	Yes	Gutter Slope (%)	2.4
No	Gutter Lip Ht (in)	0.5	No	Gutter X Slope (%)	2.2
N/A	Painted X Walk1?	No	N/A	Painted X Walk2?	No
	X Walk 1 Direction	To S		X Walk 2 Direction	To E
N/A	X Walk 1 Width (in)	N/A	N/A	X Walk 2 Width (in)	N/A
	X Walk 1 Slope (%)	1.3		X Walk 2 Slope (%)	2.9
	X Walk 1 X Slope (%)	2.1		X Walk 2 X Slope (%)	2.4

N/A	Ramp inside XWalk1?	N/A	N/A	Ramp inside XWalk2?	N/A
	Road Slope (%)	2.3	N/A	Clear Space?	Yes
	Road X Slope (%)	1.9	N/A	Clear Space to XWalk (in)	N/A
Yes	Any Obstructions?	No	Yes	Storm Grate/Utility Hazard?	No
	Obstruction Type			Storm Grate/Utility Type	
		N/A			N/A
			Yes	Surface Condition? (G/P)	Good

Remove & Replace Curb Ramp With Two New Directional Ramps or Equivalent. Remove & Replace Gutter.
