# Access Compliance Report

## Public Rights-of-Way

### (Curb Ramps)

Intersection ID: 31730	Main Street: RAISIN_TREE_LN	Cross Street: LEAF_PLUM_DR	Location: SW
ADA ID: BCC14495140E	Ramp Type: PerpDiag	Initial Pass/Fail: Fail	Overall Compliance: No
Severity Score: 8.75			
Codes/Mitigation Info/Possible Solution		Field Measurements/Component Compliance

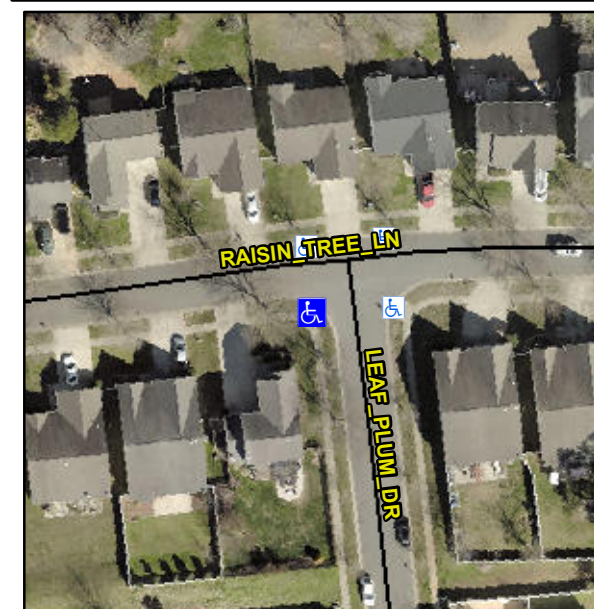
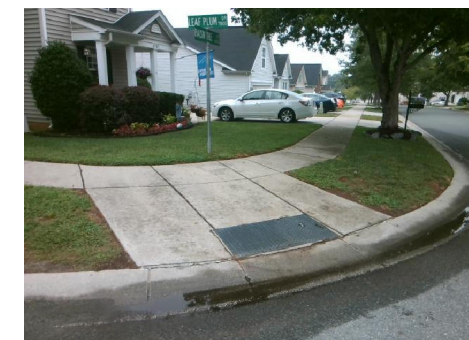
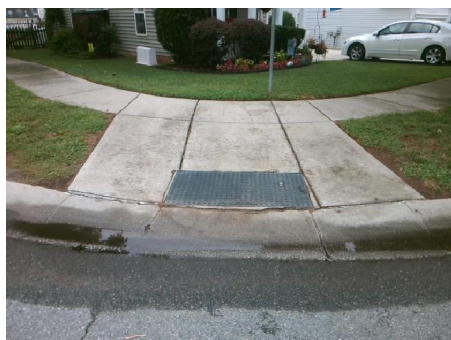
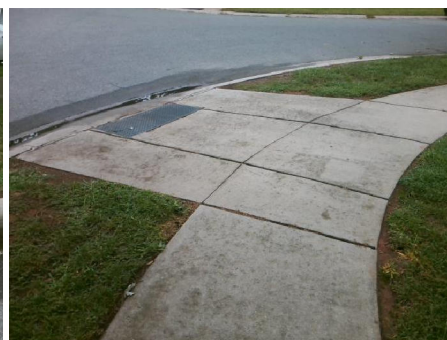
**Not Found, R304.5.1**

Compliance	Description	Data	Compliance	Description	Data
N/A	Ramp Length (in)	83.0	Yes	Ramp Slope (%)	7.3
No	Ramp Width (in)	47.0	Yes	Ramp XSlope (%)	0.0
N/A	Flare Type LT	N/A	N/A	Flare Type RT	N/A
N/A	Flare Slope LT (%)	N/A	N/A	Flare Slope RT (%)	N/A
N/A	Flare Traversable LT?	N/A	N/A	Flare Traversable RT?	N/A
N/A	Landing Length (in)	N/A	N/A	DWS Provided?	N/A
N/A	Landing Width (in)	N/A	N/A	DWS Contrast?	N/A
N/A	Landing Slope (%)	N/A	N/A	DWS Length (in)	N/A
N/A	Landing X Slope (%)	N/A	N/A	DWS Full Width?	N/A
N/A	Landing Curb? (Y/N)	N/A	N/A	DWS Offset (in)	N/A
N/A	Shared Landing?	N/A			
N/A	Gutter Ponding?	Yes	N/A	Gutter Slope (%)	N/A
N/A	Gutter Lip Ht (in)	N/A	N/A	Gutter X Slope (%)	N/A
N/A	Painted X Walk1?	No	N/A	Painted X Walk2?	No
	X Walk 1 Direction	To E		X Walk 2 Direction	To N
N/A	X Walk 1 Width (in)	N/A	N/A	X Walk 2 Width (in)	N/A
	X Walk 1 Slope (%)	5.3		X Walk 2 Slope (%)	4.6
	X Walk 1 X Slope (%)	0.3		X Walk 2 X Slope (%)	2.8

N/A	Ramp inside XWalk1?	N/A	N/A	Ramp inside XWalk2?	N/A
	Road Slope (%)	0.1	N/A	Clear Space?	N/A
	Road X Slope (%)	6.0	N/A	Clear Space to XWalk (in)	N/A
N/A	Any Obstructions?	N/A	N/A	Storm Grate/Utility Hazard?	N/A
	Obstruction Type			Storm Grate/Utility Type	
		N/A			N/A
		Yes		Surface Condition? (G/P)	Good

**Remove & Replace Curb Ramp With Two New Directional Ramps or Equivalent.**

Total Cost: \$ 3200.00
