Access Compliance Report

Public Rights-of-Way

(Curb Ramps)

Intersection ID: 42926	Main Street: KILRUSH_DR	Cross Street: LARNE_CR	Location: E
ADA ID: BCC6EDAFC147	Ramp Type: PerpDiag	Initial Pass/Fail: Fail	Overall Compliance: No
Codes/Mitigation Info/Possible Solution		Field Measurements/Component Compliance

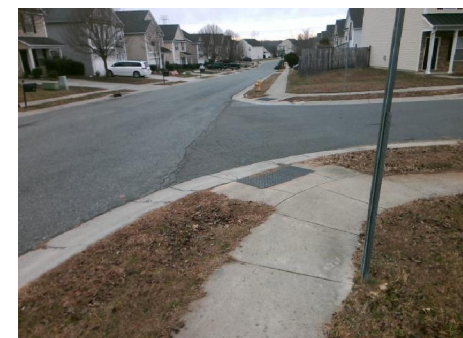
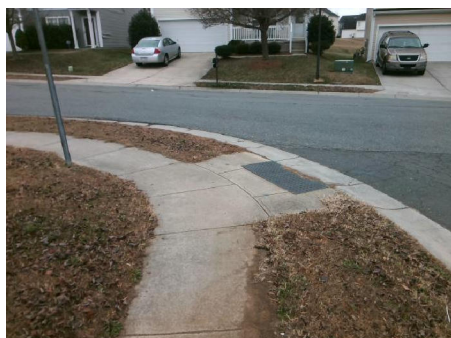
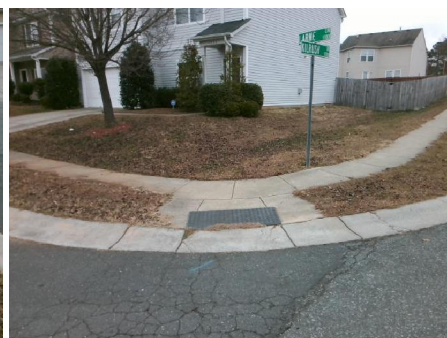
Not Found, R304.5.1, R304.5.3

Compliance	Description	Data	Compliance	Description	Data
N/A	Ramp Length (in)	43.0	Yes	Ramp Slope (%)	6.0
No	Ramp Width (in)	35.0	No	Ramp XSlope (%)	2.1
N/A	Flare Type LT	N/A	N/A	Flare Type RT	N/A
N/A	Flare Slope LT (%)	N/A	N/A	Flare Slope RT (%)	N/A
N/A	Flare Traversable LT?	N/A	N/A	Flare Traversable RT?	N/A
N/A	Landing Length (in)	N/A	N/A	DWS Provided?	N/A
N/A	Landing Width (in)	N/A	N/A	DWS Contrast?	N/A
N/A	Landing Slope (%)	N/A	N/A	DWS Length (in)	N/A
N/A	Landing X Slope (%)	N/A	N/A	DWS Full Width?	N/A
N/A	Landing Curb? (Y/N)	N/A	N/A	DWS Offset (in)	N/A
N/A	Shared Landing?	N/A			
N/A	Gutter Ponding?	N/A	N/A	Gutter Slope (%)	N/A
N/A	Gutter Lip Ht (in)	N/A	N/A	Gutter X Slope (%)	N/A
N/A	Painted X Walk1?	No	N/A	Painted X Walk2?	No
	X Walk 1 Direction	To NW		X Walk 2 Direction	To S
N/A	X Walk 1 Width (in)	N/A	N/A	X Walk 2 Width (in)	N/A
	X Walk 1 Slope (%)	2.2		X Walk 2 Slope (%)	1.4
	X Walk 1 X Slope (%)	1.6		X Walk 2 X Slope (%)	2.8

N/A	Ramp inside XWalk1?	N/A	N/A	Ramp inside XWalk2?	N/A
	Road Slope (%)	2.6	N/A	Clear Space?	N/A
	Road X Slope (%)	0.6	N/A	Clear Space to XWalk (in)	N/A
N/A	Any Obstructions?	N/A	N/A	Storm Grate/Utility Hazard?	N/A
	Obstruction Type			Storm Grate/Utility Type	
		N/A			N/A
		Yes		Surface Condition? (G/P)	Good

Remove & Replace Curb Ramp With Two New Directional Ramps or Equivalent.

Total Cost: \$ 3200.00
