Access Compliance Report

Public Rights-of-Way

(Curb Ramps)

Intersection ID: 52487	Main Street: WHITEHALL_EXECUTIVE_CENTER_DR	Cross Street: ORLICK_DR	Location: W
ADA ID: BCCBAFB19F4D	Ramp Type: Perp	Initial Pass/Fail: Fail	Overall Compliance: No
Severity Score: 12.5			
Codes/Mitigation Info/Possible Solution		Field Measurements/Component Compliance

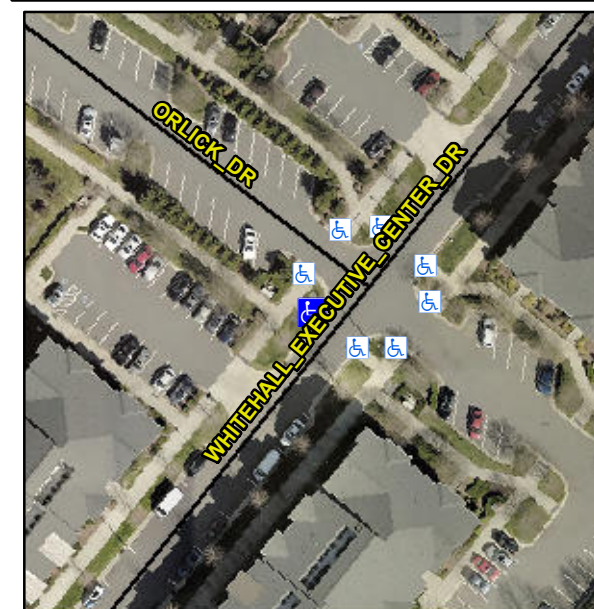
R304.2.2

Compliance	Description	Data	Compliance	Description	Data
N/A	Ramp Length (in)	81.0	No	Ramp Slope (%)	8.8
Yes	Ramp Width (in)	71.0	Yes	Ramp XSlope (%)	1.4
N/A	Flare Type LT	N/A	N/A	Flare Type RT	N/A
N/A	Flare Slope LT (%)	N/A	N/A	Flare Slope RT (%)	N/A
N/A	Flare Traversable LT?	N/A	N/A	Flare Traversable RT?	N/A
N/A	Landing Length (in)	N/A	N/A	DWS Provided?	N/A
N/A	Landing Width (in)	N/A	N/A	DWS Contrast?	N/A
N/A	Landing Slope (%)	N/A	N/A	DWS Length (in)	N/A
N/A	Landing X Slope (%)	N/A	N/A	DWS Full Width?	N/A
N/A	Landing Curb? (Y/N)	N/A	N/A	DWS Offset (in)	N/A
N/A	Shared Landing?	N/A			
N/A	Gutter Ponding?	N/A	N/A	Gutter Slope (%)	N/A
N/A	Gutter Lip Ht (in)	N/A	N/A	Gutter X Slope (%)	N/A
N/A	Painted X Walk1?	No	N/A	Painted X Walk2?	N/A
	X Walk 1 Direction	To SE		X Walk 2 Direction	N/A
N/A	X Walk 1 Width (in)	N/A	N/A	X Walk 2 Width (in)	N/A
	X Walk 1 Slope (%)	1.0		X Walk 2 Slope (%)	N/A
	X Walk 1 X Slope (%)	0.4		X Walk 2 X Slope (%)	N/A

Possible Solutions:

Remove & Replace Entire Ramp.
