# Access Compliance Report

## Public Rights-of-Way

### (Curb Ramps)

| Intersection ID: 44303 | Main Street: PAULINE_LN | Cross Street: THOMPSON_RD | Location: NW |

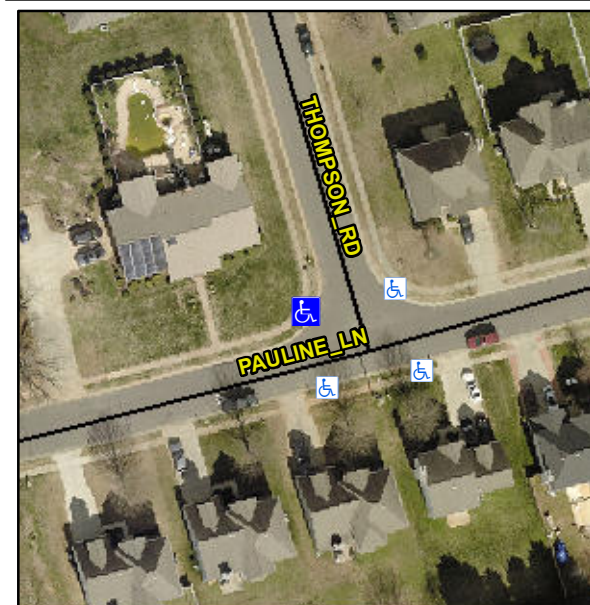
| ADA ID: BCCCC08D06F0 | Ramp Type: PerpDiag | Initial Pass/Fail: Pass | Overall Compliance: No |
| Severity Score: 5 | | | |

| Compliance | Description | Data | Compliance | Description | Data |
|---|---|---|---|---|---|
| No | Landing Length (in) | 46.0 | Yes | DWS Provided? | Yes |
| No | Landing Slope (%) | 3.1 | Yes | DWS Length (in) | 24.0 |
| N/A | Landing Curb? (Y/N) | No | No | DWS Offset (in) | 3.5 |
| Yes | Gutter Ponding? | No | No | Gutter Slope (%) | 10.1 |

Possible Solutions:

**Remove & Replace Curb Ramp With Two New Directional Ramps or Equivalent. Remove & Replace Gutter.**

**R304.2.1, R304.2.2-Perp, R304.3.2-Para, R305.2, R304.5.4**

Total Cost: \$ **3950.00**

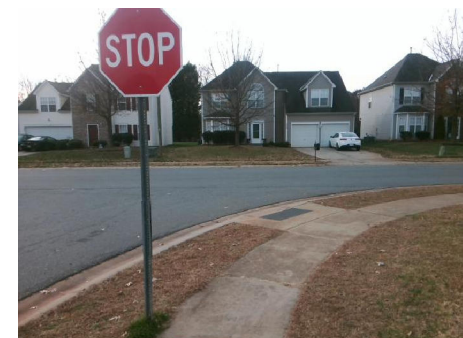
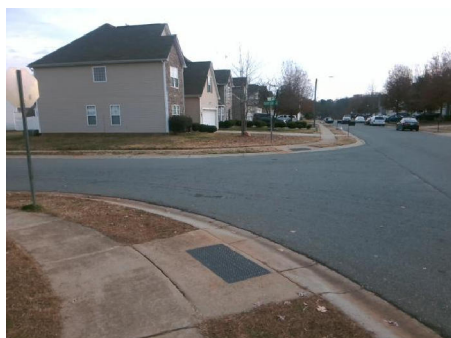
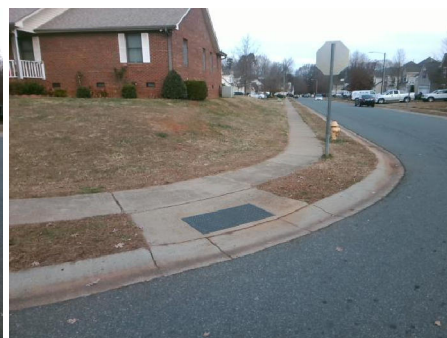
| Compliance | Description | Data | Compliance | Description | Data |
|---|---|---|---|---|---|
| | | | Yes | Surface Condition? (G/P) | Good |
