# Access Compliance Report

## Public Rights-of-Way

| Intersection ID: 27490 | Main Street: BALLANTYNE COMMONS PY | Cross Street: JOHNSTON RD | Location: SW |
| ADA ID: BCCE4E63F42C | Ramp Type: Perp | Initial Pass/Fail: Pass | Overall Compliance: No |

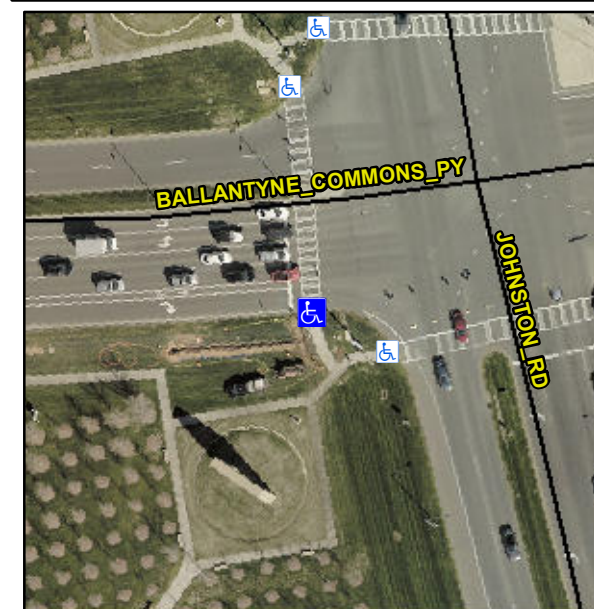
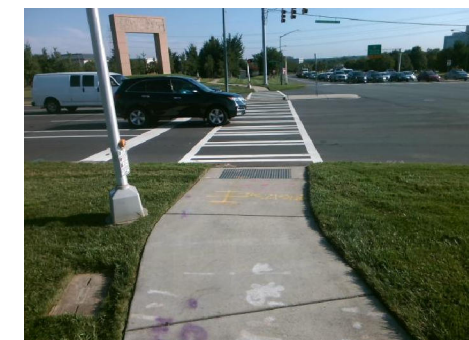
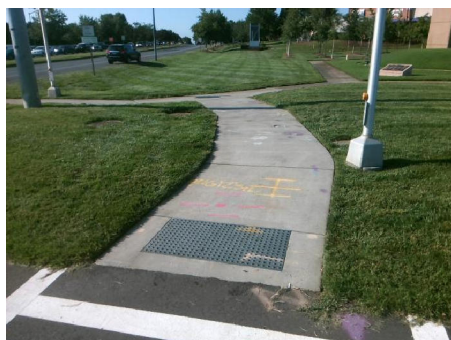
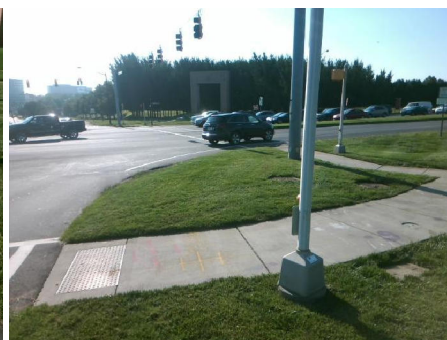
**R304.5.3, R305.2**

| Compliance | Description | Data | Compliance | Description | Data |
|---|---|---|---|---|---|
| No | Landing X Slope (%) | 3.3 | Yes | DWS Full Width? | Yes |
| N/A | Landing Curb? (Y/N) | No | No | DWS Offset (in) | 9.0 |

**Remove & Replace Entire Ramp.**

Total Cost: \$ 1850.00
