## Access Compliance Report Public Rights-of-Way (Curb Ramps)

Intersection ID: 9123Main Street:ROZZELLES\_FERRY\_RDCross Street:CORONET\_WYLocation:NADA ID: BCDC71E54C5ERamp Type:PerpInitial Pass/Fail:FailOverall Compliance:NoSeverity Score:22.5

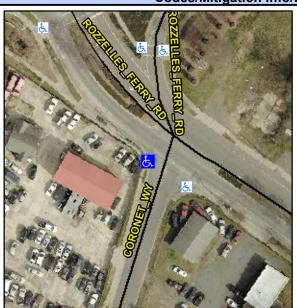
Not Found, R304.5.1, R304.2.2, R304.5.3

Field Measurements/Component Compliance							
Compl	iance Description	Data	Compl	iance	Description	Data	
N/A	Ramp Length (in)	67.0	No	Ramp	Slope (%)	9.9	
No	Ramp Width (in)	47.5	No	Ramp	XSlope (%)	2.6	
N/A	Flare Type LT	N/A	N/A	Flare	Type RT	N/A	
N/A	Flare Slope LT (%)	N/A	N/A	Flare	Slope RT (%)	N/A	
N/A	Flare Traversable LT?	N/A	N/A	Flare	Traversable RT?	N/A	
N/A	Landing Length (in)	N/A	N/A	DWS	Provided?	N/A	
N/A	Landing Width (in)	N/A	N/A	DWS	Contrast?	N/A	
N/A	Landing Slope (%)	N/A	N/A	DWS	Length (in)	N/A	
N/A	Landing X Slope (%)	N/A	N/A	DWS	Full Width?	N/A	
N/A	Landing Curb? (Y/N)	N/A	N/A	DWS	Offset (in)	N/A	
N/A	Shared Landing?	N/A					
N/A	Gutter Ponding?	N/A	N/A	Gutte	r Slope (%)	N/A	
N/A	Gutter Lip Ht (in)	N/A	N/A	Gutte	r X Slope (%)	N/A	
N/A	Painted X Walk1?	No	N/A	Paint	ed X Walk2?	N/A	
	X Walk 1 Direction	To SE		X Wa	lk 2 Direction	N/A	
N/A	X Walk 1 Width (in)	N/A	N/A	X Wa	lk 2 Width (in)	N/A

X Walk 1 Slope (%)	2.4		X Wa	lk 2 Slope (%)	N/A	
	X Walk 1 X Slope (%)	2.8		X Wa	lk 2 X Slope (%)	N/A	
N/A	Ramp inside XWalk1?	N/A	N/A	Ramp	inside XWalk2?	N/A	
	Road Slope (%)	N/A	N/A	Clear	Space?	N/A	
	Road X Slope (%)	N/A	N/A	Clear	Space to XWalk (in)	N/A	
N/A	Any Obstructions?	N/A	N/A	Storm	Grate/Utility Hazard?	N/A	
	Obstruction Type			Storm	Grate/Utility Type		
		N/A				N/A	
			Yes	Surfa	ce Condition? (G/P)	Good

Remove & Replace Entire Ramp.

1850.00
