Access Compliance Report

Public Rights-of-Way

(Curb Ramps)

Intersection ID: 14286	Main Street: S_TORRENCE_ST	Cross Street: MAIN_ST	Location: S
ADA ID: BCE1CF740CAD	Ramp Type: PerpDiag	Initial Pass/Fail: Fail	Overall Compliance: No
		Severity Score: 25

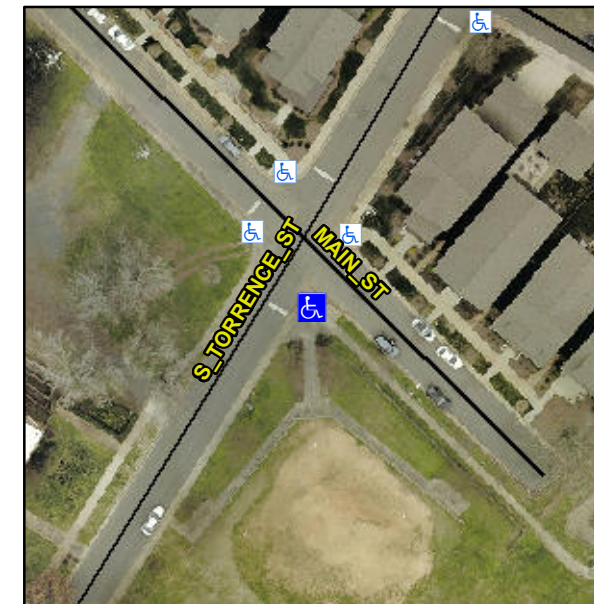
Not Found, R304.2.2

Compliance	Description	Data	Compliance	Description	Data
N/A	Ramp Length (in)	38.0	No	Ramp Slope (%)	16.7
Yes	Ramp Width (in)	48.0	Yes	Ramp XSlope (%)	1.1
N/A	Flare Type LT	N/A	N/A	Flare Type RT	N/A
N/A	Flare Slope LT (%)	N/A	N/A	Flare Slope RT (%)	N/A
N/A	Flare Traversable LT?	N/A	N/A	Flare Traversable RT?	N/A
N/A	Landing Length (in)	N/A	N/A	DWS Provided?	N/A
N/A	Landing Width (in)	N/A	N/A	DWS Contrast?	N/A
N/A	Landing Slope (%)	N/A	N/A	DWS Length (in)	N/A
N/A	Landing X Slope (%)	N/A	N/A	DWS Full Width?	N/A
N/A	Landing Curb? (Y/N)	N/A	N/A	DWS Offset (in)	N/A
N/A	Shared Landing?	N/A			
N/A	Gutter Ponding?	N/A	N/A	Gutter Slope (%)	N/A
N/A	Gutter Lip Ht (in)	N/A	N/A	Gutter X Slope (%)	N/A
N/A	Painted X Walk1?	No	N/A	Painted X Walk2?	No
	X Walk 1 Direction	To NE		X Walk 2 Direction	To NW
N/A	X Walk 1 Width (in)	N/A	N/A	X Walk 2 Width (in)	N/A
	X Walk 1 Slope (%)	1.5		X Walk 2 Slope (%)	1.1
	X Walk 1 X Slope (%)	0.6		X Walk 2 X Slope (%)	1.1

Remove & Replace Curb Ramp With Two New Directional Ramps or Equivalent.
