Access Compliance Report

Public Rights-of-Way

(Curb Ramps)

Intersection ID: 12739	Main Street: N_MCDOWELL_ST	Cross Street: E_8TH_ST	Location:	E
ADA ID: BCEADEBBA402	Ramp Type: BlendTrans1	Initial Pass/Fail: Pass	Overall Compliance: Yes	Severity Score: 0
Codes/Mitigation Info/Possible Solution		Field Measurements/Component Compliance

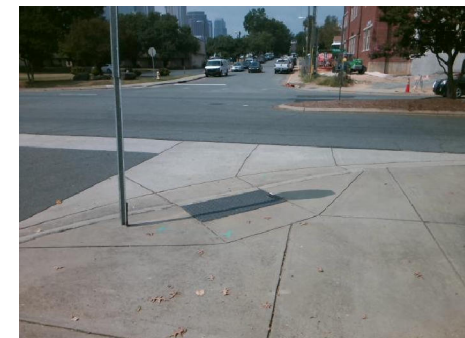
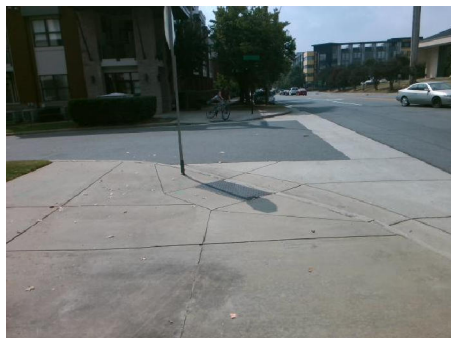
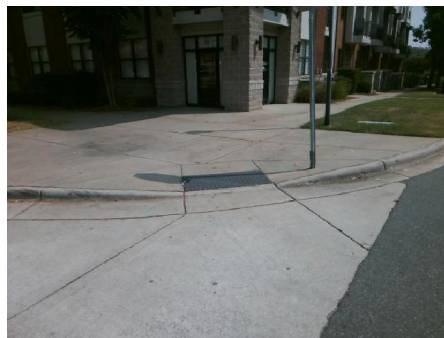
Compliance	Description	Data	Compliance	Description	Data
N/A	Ramp Length (in)	48.0	Yes	BlendTrans Slope (%)	4.2
Yes	Ramp Width (in)	48.0	Yes	BlendTrans XSlope (%)	1.1
N/A	Flare Type LT	Sloped	N/A	Flare Type RT	Sloped
Yes	Flare Slope LT (%)	7.0	Yes	Flare Slope RT (%)	6.4
N/A	Flare Traversable LT?	Yes	N/A	Flare Traversable RT?	Yes
Yes	Landing Length (in)	60.0	Yes	DWS Provided?	Yes
Yes	Landing Width (in)	60.0	Yes	DWS Contrast?	Yes
Yes	Landing Slope (%)	0.4	Yes	DWS Length (in)	24.0
Yes	Landing X Slope (%)	1.3	Yes	DWS Full Width?	Yes
N/A	Landing Curb? (Y/N)	No	Yes	DWS Offset (in)	1.0
N/A	Shared Landing?	No			
Yes	Gutter Ponding?	No	Yes	Gutter Slope (%)	1.7
Yes	Gutter Lip Ht (in)	0.0	Yes	Gutter X Slope (%)	0.4
N/A	Painted X Walk1?	No	N/A	Painted X Walk2?	No
	X Walk 1 Direction	To NW		X Walk 2 Direction	To SW
	X Walk 1 Width (in)	N/A		X Walk 2 Width (in)	N/A
	X Walk 1 Slope (%)	1.3		X Walk 2 Slope (%)	0.8
	X Walk 1 X Slope (%)	0.6		X Walk 2 X Slope (%)	3.6

N/A	Ramp inside XWalk1?	N/A	N/A	Ramp inside XWalk2?	N/A
	Road Slope (%)	0.3		Clear Space?	Yes
	Road X Slope (%)	0.6	N/A	Clear Space to XWalk (in)	N/A
Yes	Any Obstructions?	No	Yes	Storm Grate/Utility Hazard?	No
	Obstruction Type			Storm Grate/Utility Type	
		N/A			N/A
			Yes	Surface Condition? (G/P)	Good
			Yes	Curb Slope (%)	5.2
