Access Compliance Report

Public Rights-of-Way

(Curb Ramps)

Intersection ID: 8450	Main Street: INTERURBAN_AV	Cross Street: WESTRIDGE_DR	Location: NW
ADA ID: BCEC4B291820	Ramp Type: Perp	Initial Pass/Fail: Fail	Overall Compliance: No
Severity Score: 22.5			
Codes/Mitigation Info/Possible Solution		Field Measurements/Component Compliance

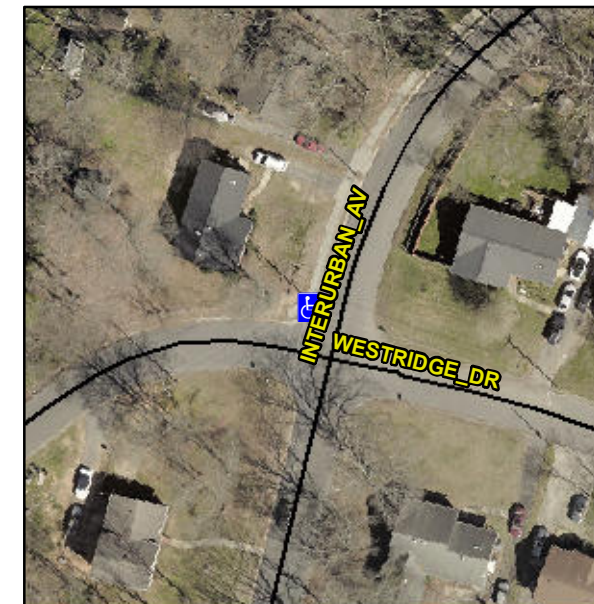
Not Found, R304.5.1, R304.2.2

Compliance	Description	Data	Compliance	Description	Data
N/A	Ramp Length (in)	23.5	No	Ramp Slope (%)	10.0
No	Ramp Width (in)	43.0	Yes	Ramp XSlope (%)	3.9
N/A	Flare Type LT	N/A	N/A	Flare Type RT	N/A
N/A	Flare Slope LT (%)	N/A	N/A	Flare Slope RT (%)	N/A
N/A	Flare Traversable LT?	N/A	N/A	Flare Traversable RT?	N/A
N/A	Landing Length (in)	N/A	N/A	DWS Provided?	N/A
N/A	Landing Width (in)	N/A	N/A	DWS Contrast?	N/A
N/A	Landing Slope (%)	N/A	N/A	DWS Length (in)	N/A
N/A	Landing X Slope (%)	N/A	N/A	DWS Full Width?	N/A
N/A	Landing Curb? (Y/N)	N/A	N/A	DWS Offset (in)	N/A
N/A	Shared Landing?	N/A			
N/A	Gutter Ponding?	N/A	N/A	Gutter Slope (%)	N/A
N/A	Gutter Lip Ht (in)	N/A	N/A	Gutter X Slope (%)	N/A
N/A	Painted X Walk1?	No	N/A	Painted X Walk2?	N/A
	X Walk 1 Direction	To S		X Walk 2 Direction	N/A
N/A	X Walk 1 Width (in)	N/A	N/A	X Walk 2 Width (in)	N/A
	X Walk 1 Slope (%)	0.7		X Walk 2 Slope (%)	N/A
	X Walk 1 X Slope (%)	6.6		X Walk 2 X Slope (%)	N/A

Remove & Replace Entire Ramp.

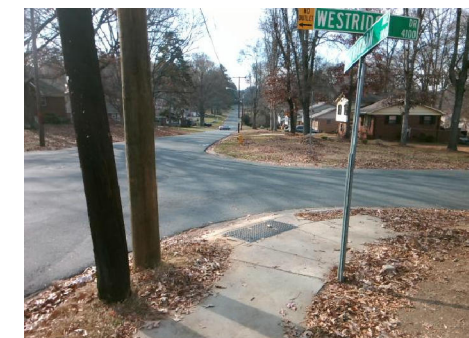
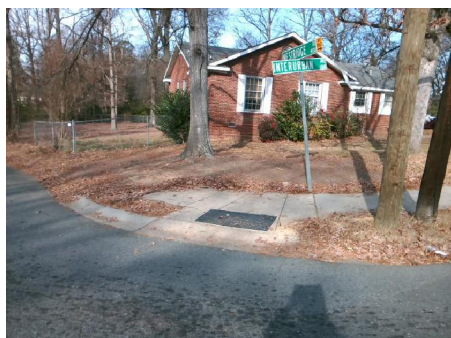
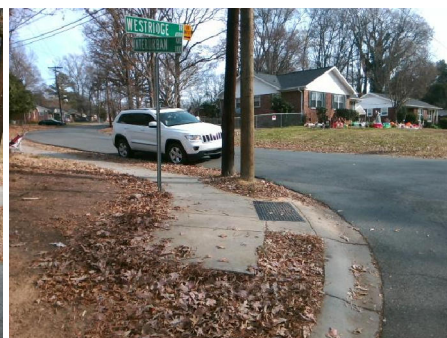
N/A	Ramp inside XWalk1?	N/A	N/A	Ramp inside XWalk2?	N/A
	Road Slope (%)	6.6	N/A	Clear Space?	N/A
	Road X Slope (%)	0.7	N/A	Clear Space to XWalk (in)	N/A
N/A	Any Obstructions?	N/A	N/A	Storm Grate/Utility Hazard?	N/A
	Obstruction Type			Storm Grate/Utility Type	
		N/A			N/A
			Yes	Surface Condition? (G/P)	Good
