Access Compliance Report

Public Rights-of-Way

(Curb Ramps)

Intersection ID: 10198	Main Street: FONTANA_AV	Cross Street: REMBERT_CT	Location: SE
ADA ID: BCF011B6C30F	Ramp Type: Perp	Initial Pass/Fail: Fail	Overall Compliance: No
Codes/Mitigation Info/Possible Solution		Field Measurements/Component Compliance

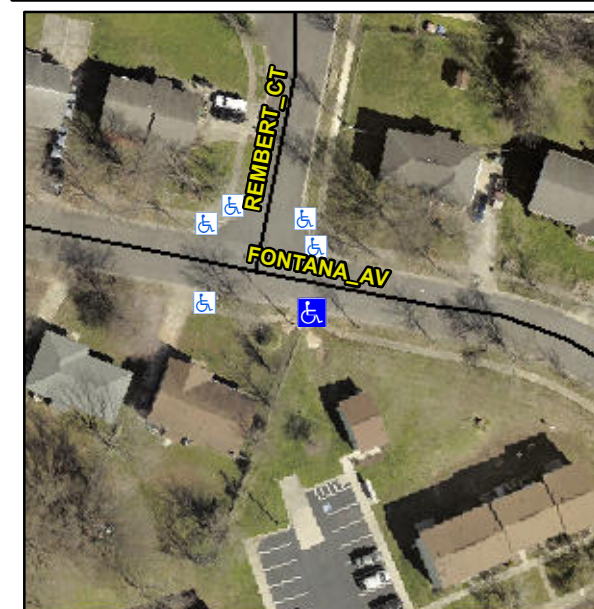
Compliance	Description	Data	Compliance	Description	Data
N/A	Ramp Length (in)	48.0	No	Ramp Slope (%)	10.6
Yes	Ramp Width (in)	48.0	Yes	Ramp XSlope (%)	4.4
N/A	Flare Type LT	N/A	N/A	Flare Type RT	N/A
N/A	Flare Slope LT (%)	N/A	N/A	Flare Slope RT (%)	N/A
N/A	Flare Traversable LT?	N/A	N/A	Flare Traversable RT?	N/A
N/A	Landing Length (in)	N/A	N/A	DWS Provided?	N/A
N/A	Landing Width (in)	N/A	N/A	DWS Contrast?	N/A
N/A	Landing Slope (%)	N/A	N/A	DWS Length (in)	N/A
N/A	Landing X Slope (%)	N/A	N/A	DWS Full Width?	N/A
N/A	Landing Curb? (Y/N)	N/A	N/A	DWS Offset (in)	N/A
N/A	Shared Landing?	N/A			
N/A	Gutter Ponding?	N/A	N/A	Gutter Slope (%)	N/A
N/A	Gutter Lip Ht (in)	N/A	N/A	Gutter X Slope (%)	N/A
N/A	Painted X Walk1?	No	N/A	Painted X Walk2?	N/A
	X Walk 1 Direction	To N		X Walk 2 Direction	N/A
N/A	X Walk 1 Width (in)	N/A	N/A	X Walk 2 Width (in)	N/A
	X Walk 1 Slope (%)	2.6		X Walk 2 Slope (%)	N/A
	X Walk 1 X Slope (%)	5.0		X Walk 2 X Slope (%)	N/A

N/A	Ramp inside XWalk1?	N/A	N/A	Ramp inside XWalk2?	N/A
	Road Slope (%)	N/A	N/A	Clear Space?	N/A
	Road X Slope (%)	N/A	N/A	Clear Space to XWalk (in)	N/A
N/A	Any Obstructions?	N/A	N/A	Storm Grate/Utility Hazard?	N/A
	Obstruction Type			Storm Grate/Utility Type	
		N/A			N/A
			Yes	Surface Condition? (G/P)	Good

Possible Solutions:

Remove & Replace Entire Ramp.
