Access Compliance Report

Public Rights-of-Way

(Curb Ramps)

Intersection ID: 12020	Main Street: E_W_T_HARRIS_BV	Cross Street: TANTILLA_CR	Location: SW
ADA ID: BCF8960DA800	Ramp Type: PerpDiag	Initial Pass/Fail: Fail	Overall Compliance: No
Severity Score: 25			
Codes/Mitigation Info/Possible Solution		Field Measurements/Component Compliance

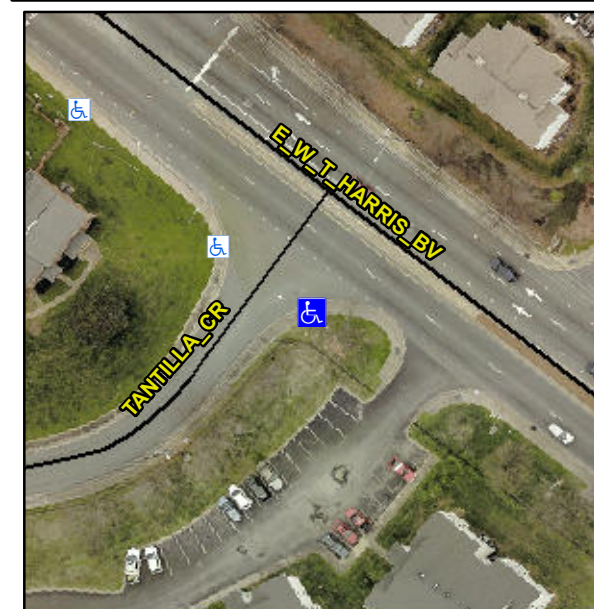
Compliance	Description	Data	Compliance	Description	Data
N/A	Ramp Length (in)	60.0	No	Ramp Slope (%)	12.8
Yes	Ramp Width (in)	48.0	Yes	Ramp XSlope (%)	1.5
N/A	Flare Type LT	N/A	N/A	Flare Type RT	N/A
N/A	Flare Slope LT (%)	N/A	N/A	Flare Slope RT (%)	N/A
N/A	Flare Traversable LT?	N/A	N/A	Flare Traversable RT?	N/A
N/A	Landing Length (in)	N/A	N/A	DWS Provided?	N/A
N/A	Landing Width (in)	N/A	N/A	DWS Contrast?	N/A
N/A	Landing Slope (%)	N/A	N/A	DWS Length (in)	N/A
N/A	Landing X Slope (%)	N/A	N/A	DWS Full Width?	N/A
N/A	Landing Curb? (Y/N)	N/A	N/A	DWS Offset (in)	N/A
N/A	Shared Landing?	N/A			
N/A	Gutter Ponding?	N/A	N/A	Gutter Slope (%)	N/A
N/A	Gutter Lip Ht (in)	N/A	N/A	Gutter X Slope (%)	N/A
N/A	Painted X Walk1?	No	N/A	Painted X Walk2?	No
	X Walk 1 Direction	To NE		X Walk 2 Direction	To NW
N/A	X Walk 1 Width (in)	N/A	N/A	X Walk 2 Width (in)	N/A
	X Walk 1 Slope (%)	3.7		X Walk 2 Slope (%)	1.7
	X Walk 1 X Slope (%)	0.2		X Walk 2 X Slope (%)	3.6

N/A	Ramp inside XWalk1?	N/A	N/A	Ramp inside XWalk2?	N/A
	Road Slope (%)	2.3	N/A	Clear Space?	N/A
	Road X Slope (%)	4.6	N/A	Clear Space to XWalk (in)	N/A
N/A	Any Obstructions?	N/A	N/A	Storm Grate/Utility Hazard?	N/A
	Obstruction Type			Storm Grate/Utility Type	
		N/A			N/A
			Yes	Surface Condition? (G/P)	Good

Possible Solutions:

Remove & Replace Curb Ramp With Two New Directional Ramps or Equivalent.

Not Found, R304.2.2
