Access Compliance Report

Public Rights-of-Way

(Curb Ramps)

Intersection ID: 5421	Main Street: SUNSET_RD	Cross Street: OLD_STATESVILLE_RD	Location: S
ADA ID: BD0D45E9F4CD	Ramp Type: Perp	Initial Pass/Fail: Fail	Overall Compliance: No
Severity Score: 21.25			
Codes/Mitigation Info/Possible Solution		Field Measurements/Component Compliance

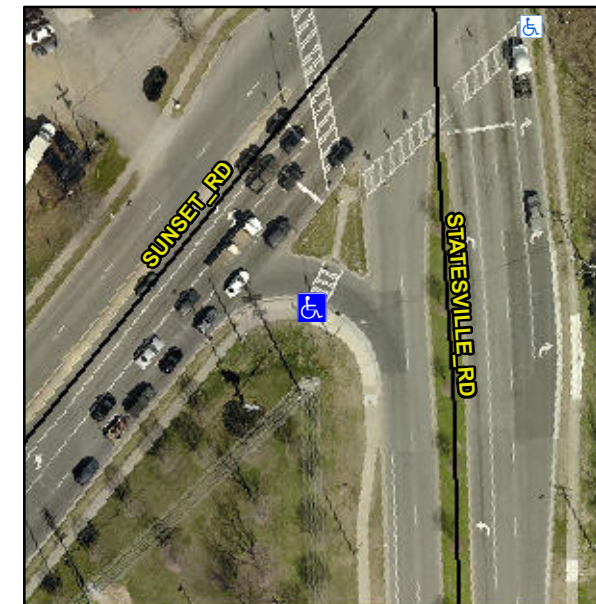
Not Found, R304.5.1, R304.2.2

Compliance	Description	Data	Compliance	Description	Data
N/A	Ramp Length (in)	64.5	No	Ramp Slope (%)	8.9
No	Ramp Width (in)	40.5	Yes	Ramp XSlope (%)	1.2
N/A	Flare Type LT	N/A	N/A	Flare Type RT	N/A
N/A	Flare Slope LT (%)	N/A	N/A	Flare Slope RT (%)	N/A
N/A	Flare Traversable LT?	N/A	N/A	Flare Traversable RT?	N/A
N/A	Landing Length (in)	N/A	N/A	DWS Provided?	N/A
N/A	Landing Width (in)	N/A	N/A	DWS Contrast?	N/A
N/A	Landing Slope (%)	N/A	N/A	DWS Length (in)	N/A
N/A	Landing X Slope (%)	N/A	N/A	DWS Full Width?	N/A
N/A	Landing Curb? (Y/N)	N/A	N/A	DWS Offset (in)	N/A
N/A	Shared Landing?	N/A			
N/A	Gutter Ponding?	N/A	N/A	Gutter Slope (%)	N/A
N/A	Gutter Lip Ht (in)	N/A	N/A	Gutter X Slope (%)	N/A
N/A	Painted X Walk1?	Yes	N/A	Painted X Walk2?	N/A
	X Walk 1 Direction	To N		X Walk 2 Direction	N/A
N/A	X Walk 1 Width (in)	122.0	N/A	X Walk 2 Width (in)	N/A
	X Walk 1 Slope (%)	0.4		X Walk 2 Slope (%)	N/A
	X Walk 1 X Slope (%)	0.4		X Walk 2 X Slope (%)	N/A

N/A	Ramp inside XWalk1?	Yes	N/A	Ramp inside XWalk2?	N/A
	Road Slope (%)	N/A	N/A	Clear Space?	N/A
	Road X Slope (%)	N/A	N/A	Clear Space to XWalk (in)	N/A
N/A	Any Obstructions?	N/A	N/A	Storm Grate/Utility Hazard?	N/A
	Obstruction Type			Storm Grate/Utility Type	
		N/A			N/A
			Yes	Surface Condition? (G/P)	Good

Remove & Replace Entire Ramp.
