# Access Compliance Report Public Rights-of-Way (Curb Ramps)

Intersection ID: 7344	Main Street: LOG_CABIN_RD	Cross Street: TOM_HUNTER_RD	Location: SW
ADA ID: BD171FB03694	Ramp Type: PerpDiag	Initial Pass/Fail: Fail	Overall Compliance: No Severity Score: 10

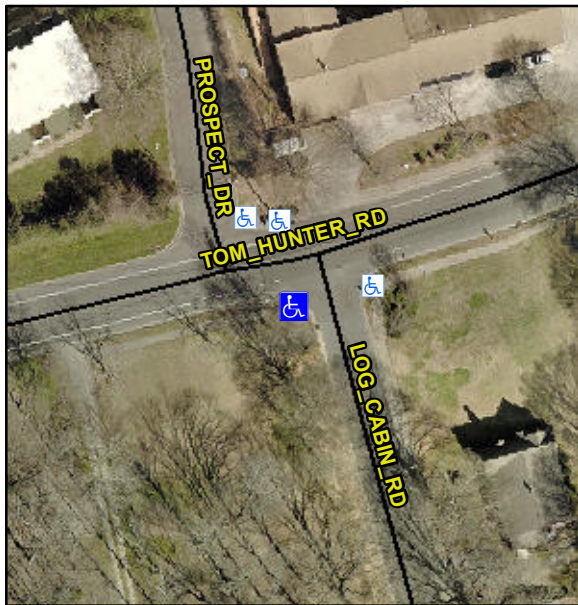
**Not Found, R304.5.1, R304.5.3**

Compliance	Description	Data	Compliance	Description	Data
N/A	Ramp Length (in)	47.0	Yes	Ramp Slope (%)	7.9
No	Ramp Width (in)	47.0	No	Ramp XSlope (%)	2.7
N/A	Flare Type LT	N/A	N/A	Flare Type RT	N/A
N/A	Flare Slope LT (%)	N/A	N/A	Flare Slope RT (%)	N/A
N/A	Flare Traversable LT?	N/A	N/A	Flare Traversable RT?	N/A
N/A	Landing Length (in)	N/A	N/A	DWS Provided?	N/A
N/A	Landing Width (in)	N/A	N/A	DWS Contrast?	N/A
N/A	Landing Slope (%)	N/A	N/A	DWS Length (in)	N/A
N/A	Landing X Slope (%)	N/A	N/A	DWS Full Width?	N/A
N/A	Landing Curb? (Y/N)	N/A	N/A	DWS Offset (in)	N/A
N/A	Shared Landing?	N/A			
N/A	Gutter Ponding?	N/A	N/A	Gutter Slope (%)	N/A
N/A	Gutter Lip Ht (in)	N/A	N/A	Gutter X Slope (%)	N/A
N/A	Painted X Walk1?	No	N/A	Painted X Walk2?	No
	X Walk 1 Direction	To E		X Walk 2 Direction	To N
N/A	X Walk 1 Width (in)	N/A	N/A	X Walk 2 Width (in)	N/A
	X Walk 1 Slope (%)	1.9		X Walk 2 Slope (%)	0.8
	X Walk 1 X Slope (%)	0.7		X Walk 2 X Slope (%)	0.2

N/A	Ramp inside XWalk1?	N/A	N/A	Ramp inside XWalk2?	N/A
	Road Slope (%)	2.1	N/A	Clear Space?	N/A
	Road X Slope (%)	1.3	N/A	Clear Space to XWalk (in)	N/A
N/A	Any Obstructions?	N/A	N/A	Storm Grate/Utility Hazard?	N/A
	Obstruction Type			Storm Grate/Utility Type	
		N/A			N/A
			Yes	Surface Condition? (G/P)	Good

**Remove & Replace Curb Ramp With Two New Directional Ramps or Equivalent.**
