Access Compliance Report

Public Rights-of-Way

(Curb Ramps)

Intersection ID: 45139	Main Street: SHOCCO_LN	Cross Street: FOUR_SISTERS_LN	Location: NW
ADA ID: BD1F5687B1D3	Ramp Type: BlendTrans1	Initial Pass/Fail: Fail	Overall Compliance: No
		Severity Score: 8.75	
Codes/Mitigation Info/Possible Solution		Field Measurements/Component Compliance

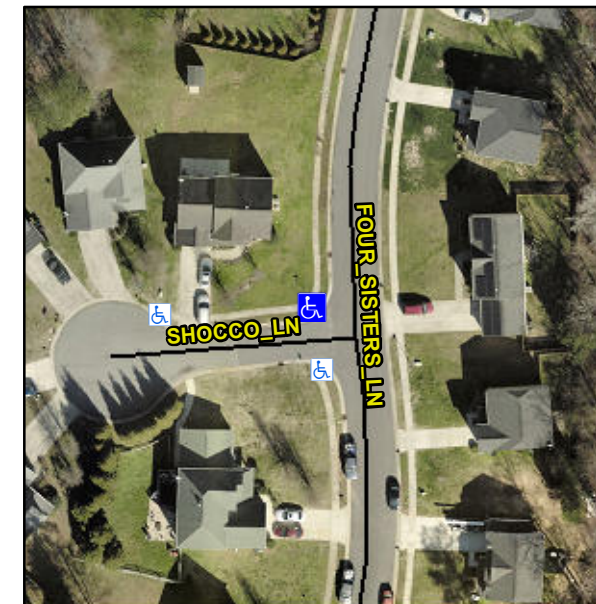
CURB LIP 0.5

Not Found, R304.5.1

Possible Solutions:

Remove & Replace Curb Ramp With Two New Directional Ramps or Equivalent.

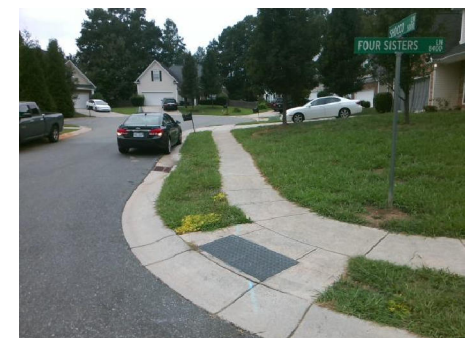
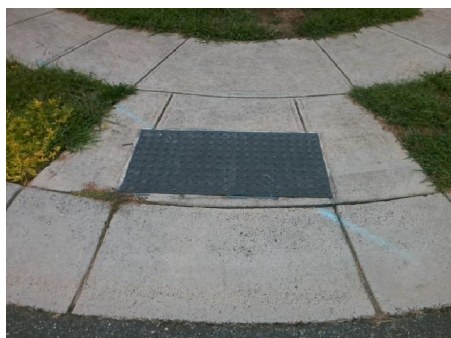
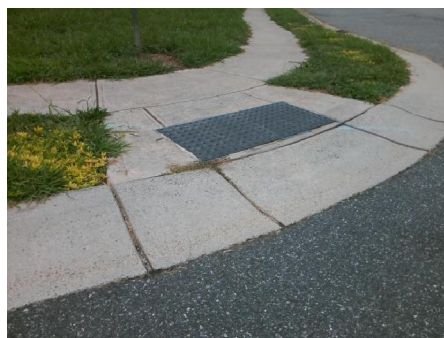
Compliance	Description	Data	Compliance	Description	Data
N/A	Ramp Length (in)	45.0	Yes	BlendTrans Slope (%)	4.9
No	Ramp Width (in)	38.0	Yes	BlendTrans XSlope (%)	1.3
N/A	Flare Type LT	N/A	N/A	Flare Type RT	N/A
N/A	Flare Slope LT (%)	N/A	N/A	Flare Slope RT (%)	N/A
N/A	Flare Traversable LT?	N/A	N/A	Flare Traversable RT?	N/A
N/A	Landing Length (in)	N/A	N/A	DWS Provided?	N/A
N/A	Landing Width (in)	N/A	N/A	DWS Contrast?	N/A
N/A	Landing Slope (%)	N/A	N/A	DWS Length (in)	N/A
N/A	Landing X Slope (%)	N/A	N/A	DWS Full Width?	N/A
N/A	Landing Curb? (Y/N)	N/A	N/A	DWS Offset (in)	N/A
N/A	Shared Landing?	N/A			
N/A	Gutter Ponding?	N/A	N/A	Gutter Slope (%)	N/A
N/A	Gutter Lip Ht (in)	N/A	N/A	Gutter X Slope (%)	N/A
N/A	Painted X Walk1?	No	N/A	Painted X Walk2?	No
	X Walk 1 Direction	To S		X Walk 2 Direction	To E
	X Walk 1 Width (in)	N/A		X Walk 2 Width (in)	N/A
	X Walk 1 Slope (%)	1.5		X Walk 2 Slope (%)	1.3
	X Walk 1 X Slope (%)	3.9		X Walk 2 X Slope (%)	0.4

N/A	Ramp inside XWalk1?	N/A	N/A	Ramp inside XWalk2?	N/A
	Road Slope (%)	2.0		Clear Space?	N/A
	Road X Slope (%)	2.2	N/A	Clear Space to XWalk (in)	N/A
N/A	Any Obstructions?	N/A	N/A	Storm Grate/Utility Hazard?	N/A
	Obstruction Type			Storm Grate/Utility Type	
		N/A			N/A
			Yes	Surface Condition? (G/P)	Good
			No	Curb Slope (%)	11.6
