Access Compliance Report

Public Rights-of-Way

(Curb Ramps)

Intersection ID: 21505	Main Street: COTILLION_AV	Cross Street: REBEL_DR	Location:	S
ADA ID: BD220FA00E3B	Ramp Type: Directional1	Initial Pass/Fail: Fail	Overall Compliance: No	Severity Score: 10
Codes/Mitigation Info/Possible Solution		Field Measurements/Component Compliance

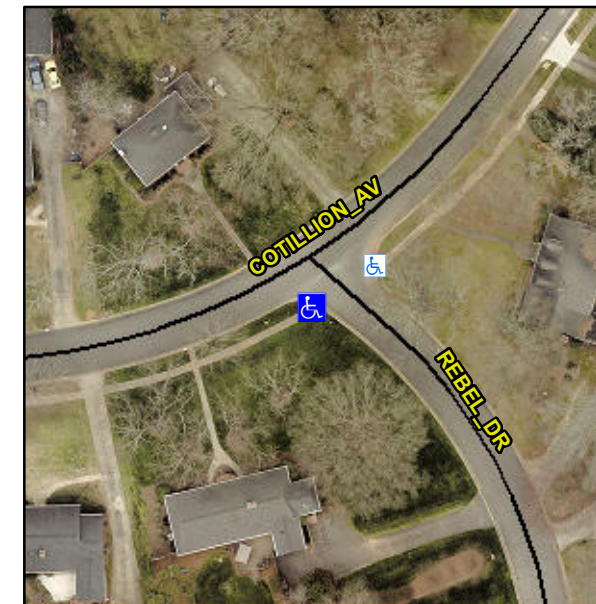
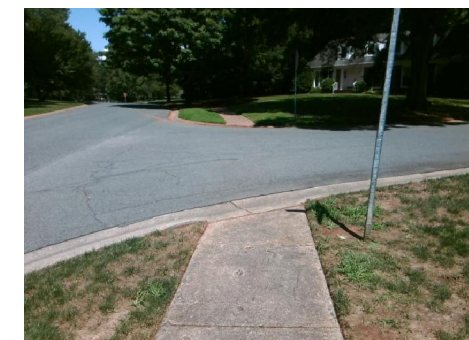
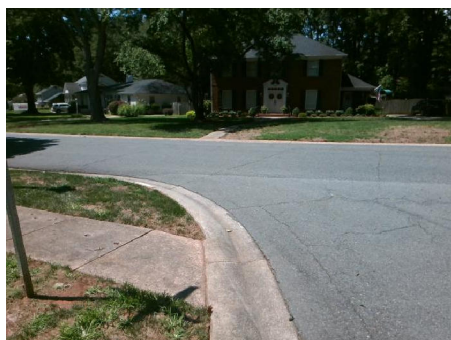
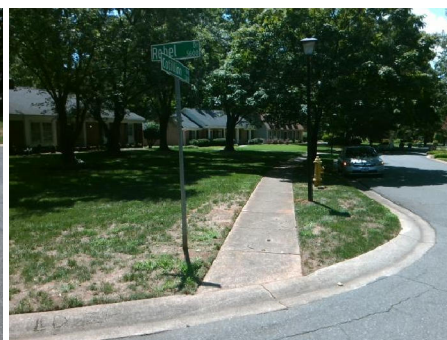
Compliance	Description	Data	Compliance	Description	Data
N/A	Ramp Length (in)	29.0	N/A	Grade Break?	N/A
No	Ramp Width (in)	47.5	N/A	Grade Break Slope (%)	0.0
Yes	Ramp Slope (%)	3.8	N/A	Grade Break XSlope (%)	0.0
No	Ramp XSlope (%)	4.0			
N/A	Flare Type LT	N/A	N/A	Flare Type RT	N/A
N/A	Flare Slope LT (%)	N/A	N/A	Flare Slope RT (%)	0.0
N/A	Flare Traversable LT?	N/A	N/A	Flare Traversable RT?	N/A
N/A	Landing Length (in)	0.0	N/A	DWS Provided?	N/A
N/A	Landing Width (in)	0.0	N/A	DWS Contrast?	N/A
N/A	Landing Slope (%)	0.0	N/A	DWS Length (in)	N/A
N/A	Landing X Slope (%)	0.0	N/A	DWS Full Width?	N/A
N/A	Landing Curb? (Y/N)	N/A	N/A	DWS Offset LT (in)	N/A
N/A	Shared Landing?	N/A	N/A	DWS Offset RT (in)	N/A
N/A	Gutter Ponding?	0.0	N/A	Gutter Slope (%)	N/A
N/A	Gutter Lip Ht (in)	0.0	N/A	Gutter X Slope (%)	N/A
N/A	Painted X Walk1?	No		Road Slope (%)	6.7
	X Walk 1 Direction	To NE		Road X Slope (%)	0.8
	X Walk 1 Width (in)	N/A		Clear Space?	N/A

X Walk 1 Slope (%)	6.7	N/A	Clear Space to XWalk (in)	N/A
	X Walk 1 X Slope (%)	0.8	N/A	Storm Grate/Utility Hazard?	N/A
N/A	Ramp inside XWalk1?	N/A		Storm Grate/Utility Type	
N/A	Any Obstructions?	N/A			N/A
	Obstruction Type		Yes	Surface Condition? (G/P)	Good
			N/A	Curb Slope (%)	14.8

Possible Solutions:

Remove & Replace Entire Ramp.

R304.5.1, R304.5.3
