Access Compliance Report

Public Rights-of-Way

(Curb Ramps)

Intersection ID: 10025240	Main Street: DURANT_BV	Cross Street: N/A	Location:	N
ADA ID: BD253C6FB29D	Ramp Type: BlendTrans1	Initial Pass/Fail: Fail	Overall Compliance: No	Severity Score: 8.75
Codes/Mitigation Info/Possible Solution		Field Measurements/Component Compliance

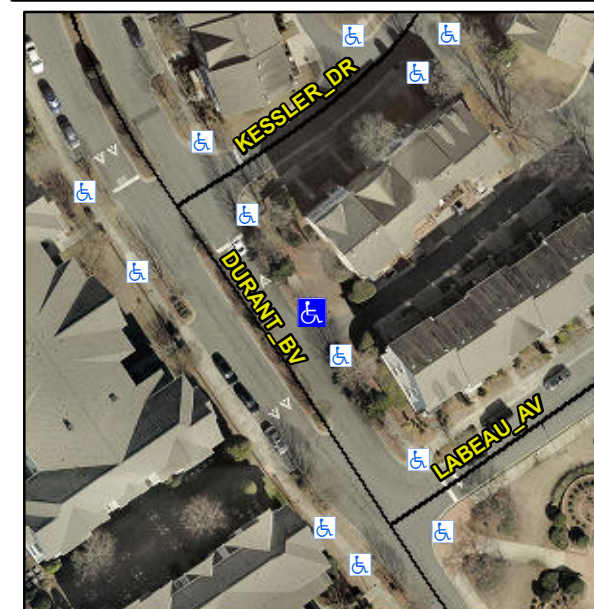
Compliance	Description	Data	Compliance	Description	Data
N/A	Ramp Length (in)	72.0	Yes	BlendTrans Slope (%)	1.6
No	Ramp Width (in)	44.0	Yes	BlendTrans XSlope (%)	0.7
N/A	Flare Type LT	N/A	N/A	Flare Type RT	N/A
N/A	Flare Slope LT (%)	N/A	N/A	Flare Slope RT (%)	N/A
N/A	Flare Traversable LT?	N/A	N/A	Flare Traversable RT?	N/A
N/A	Landing Length (in)	N/A	N/A	DWS Provided?	N/A
N/A	Landing Width (in)	N/A	N/A	DWS Contrast?	N/A
N/A	Landing Slope (%)	N/A	N/A	DWS Length (in)	N/A
N/A	Landing X Slope (%)	N/A	N/A	DWS Full Width?	N/A
N/A	Landing Curb? (Y/N)	N/A	N/A	DWS Offset (in)	N/A
N/A	Shared Landing?	N/A			
N/A	Gutter Ponding?	N/A	N/A	Gutter Slope (%)	N/A
N/A	Gutter Lip Ht (in)	N/A	N/A	Gutter X Slope (%)	N/A
N/A	Painted X Walk1?	No	N/A	Painted X Walk2?	No
	X Walk 1 Direction	To W		X Walk 2 Direction	To SE
	X Walk 1 Width (in)	N/A		X Walk 2 Width (in)	N/A
	X Walk 1 Slope (%)	3.1		X Walk 2 Slope (%)	4.3
	X Walk 1 X Slope (%)	6.4		X Walk 2 X Slope (%)	3.2

N/A	Ramp inside XWalk1?	N/A	N/A	Ramp inside XWalk2?	N/A
	Road Slope (%)	0.9		Clear Space?	N/A
	Road X Slope (%)	6.4	N/A	Clear Space to XWalk (in)	N/A
N/A	Any Obstructions?	N/A	N/A	Storm Grate/Utility Hazard?	N/A
	Obstruction Type			Storm Grate/Utility Type	
		N/A			N/A
			Yes	Surface Condition? (G/P)	Good
			N/A	Curb Slope (%)	1.4

Possible Solutions:

Remove & Replace Curb Ramp With Two New Directional Ramps or Equivalent.

R304.5.1

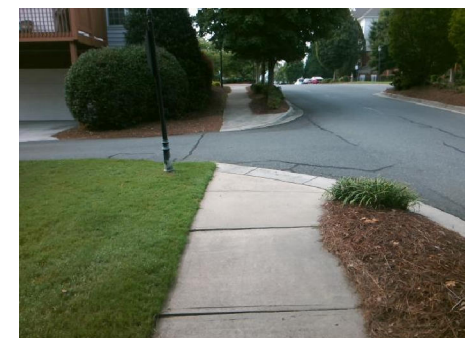
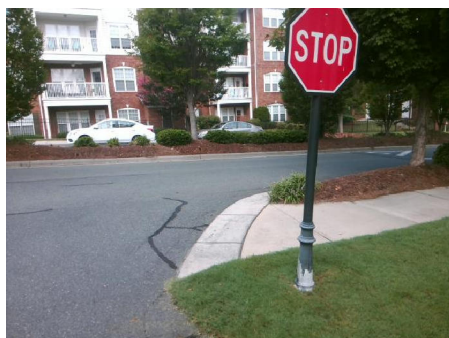
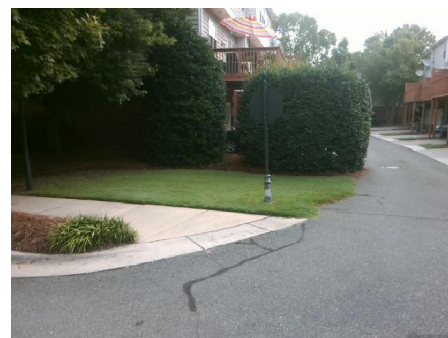
Street 1 Name DURANT BV
 Stop Condition-Street 1 None
 Street 2 Name N/A
 Stop Condition-Street 2 StopSign
