Access Compliance Report

Public Rights-of-Way

(Curb Ramps)

Intersection ID: 27020	Main Street: LINKS_DR	Cross Street: SETON_HOUSE_LN	Location:	N
ADA ID: BD2D640BA797	Ramp Type: Perp	Initial Pass/Fail: Fail	Overall Compliance: No	Severity Score: 21.25
Codes/Mitigation Info/Possible Solution		Field Measurements/Component Compliance

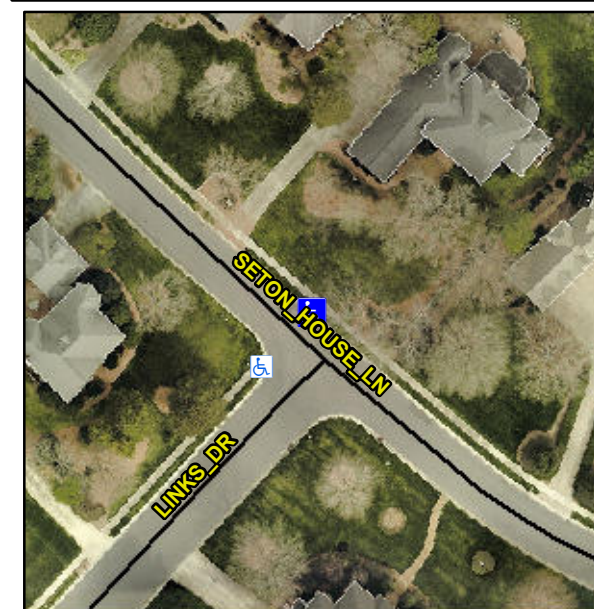
Not Found, R304.5.1, R304.2.2

Compliance	Description	Data	Compliance	Description	Data
N/A	Ramp Length (in)	93.0	No	Ramp Slope (%)	10.2
No	Ramp Width (in)	47.5	Yes	Ramp XSlope (%)	0.1
N/A	Flare Type LT	N/A	N/A	Flare Type RT	N/A
N/A	Flare Slope LT (%)	N/A	N/A	Flare Slope RT (%)	N/A
N/A	Flare Traversable LT?	N/A	N/A	Flare Traversable RT?	N/A
N/A	Landing Length (in)	N/A	N/A	DWS Provided?	N/A
N/A	Landing Width (in)	N/A	N/A	DWS Contrast?	N/A
N/A	Landing Slope (%)	N/A	N/A	DWS Length (in)	N/A
N/A	Landing X Slope (%)	N/A	N/A	DWS Full Width?	N/A
N/A	Landing Curb? (Y/N)	N/A	N/A	DWS Offset (in)	N/A
N/A	Shared Landing?	N/A			
N/A	Gutter Ponding?	N/A	N/A	Gutter Slope (%)	N/A
N/A	Gutter Lip Ht (in)	N/A	N/A	Gutter X Slope (%)	N/A
N/A	Painted X Walk1?	No	N/A	Painted X Walk2?	N/A
	X Walk 1 Direction	To SW		X Walk 2 Direction	N/A
N/A	X Walk 1 Width (in)	N/A	N/A	X Walk 2 Width (in)	N/A
	X Walk 1 Slope (%)	3.5		X Walk 2 Slope (%)	N/A
	X Walk 1 X Slope (%)	1.9		X Walk 2 X Slope (%)	N/A

N/A	Ramp inside XWalk1?	N/A	N/A	Ramp inside XWalk2?	N/A
	Road Slope (%)	N/A	N/A	Clear Space?	N/A
	Road X Slope (%)	N/A	N/A	Clear Space to XWalk (in)	N/A
N/A	Any Obstructions?	N/A	N/A	Storm Grate/Utility Hazard?	N/A
	Obstruction Type			Storm Grate/Utility Type	
		N/A			N/A
			Yes	Surface Condition? (G/P)	Good

Possible Solutions:

Remove & Replace Entire Ramp.

Total Cost: \$ 1850.00
