# Access Compliance Report

## Public Rights-of-Way

### (Curb Ramps)

Intersection ID: 9230	Main Street: QUIET_COVE_CT	Cross Street: THE_PLAZA	Location: NE
ADA ID: BD323CCBA97A	Ramp Type: Combination2Diag	Initial Pass/Fail: Fail	Overall Compliance: No
Severity Score: 0			
Codes/Mitigation Info/Possible Solution		Field Measurements/Component Compliance

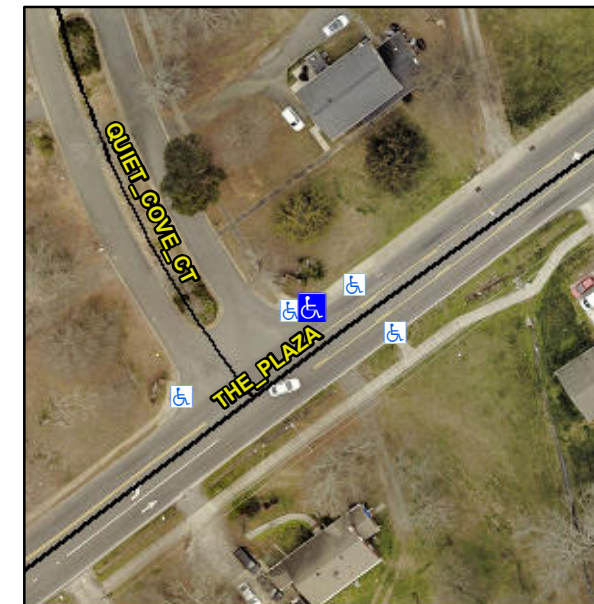
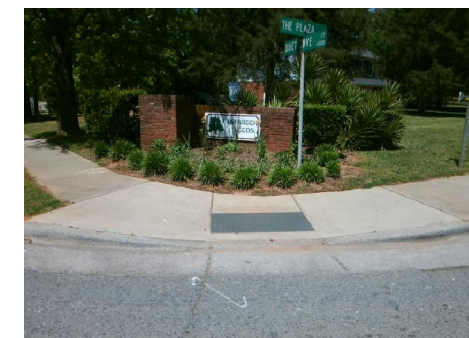
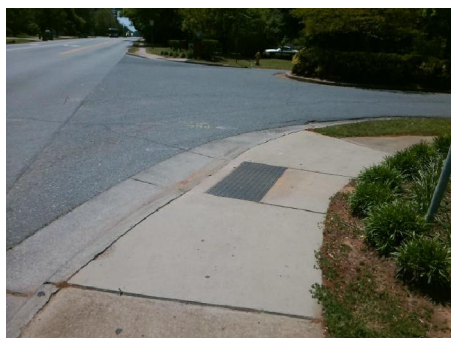
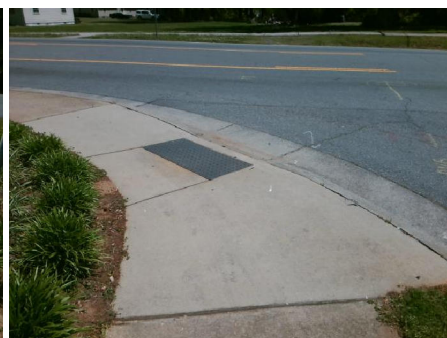
**LT RP < 5%**

**Not Found, R304.5.1, R304.5.3**

Compliance	Description	Data	Compliance	Description	Data
N/A	Ramp Length LT (in)	49.0	N/A	Ramp Length RT (in)	59.0
Yes	Ramp Width LT (in)	55.0	Yes	Ramp Width RT (in)	60.0
Yes	Ramp Slope LT (%)	3.6	Yes	Ramp Slope RT (%)	6.1
Yes	Ramp XSlope LT (%)	1.6	No	Ramp XSlope RT (%)	3.4
N/A	Ramp Length (in)	59.0	Yes	Ramp Slope (%)	3.7
No	Ramp Width (in)	46.5	Yes	Ramp XSlope (%)	0.3
N/A	Flare Type LT	N/A	N/A	Flare Type RT	N/A
N/A	Flare Slope LT (%)	N/A	N/A	Flare Slope RT (%)	N/A
N/A	Flare Traversable LT?	N/A	N/A	Flare Traversable RT?	N/A
N/A	Landing Length (in)	N/A	N/A	DWS Provided?	N/A
N/A	Landing Width (in)	N/A	N/A	DWS Contrast?	N/A
N/A	Landing Slope (%)	N/A	N/A	DWS Length (in)	N/A
N/A	Landing X Slope (%)	N/A	N/A	DWS Full Width?	N/A
N/A	Landing Curb? (Y/N)	N/A	N/A	DWS Offset (in)	N/A
N/A	Shared Landing?	N/A			
N/A	Gutter Ponding?	N/A	N/A	Gutter Slope (%)	N/A
N/A	Gutter Lip Ht (in)	N/A	N/A	Gutter X Slope (%)	N/A
N/A	Painted X Walk1?	No	N/A	Painted X Walk2?	No

X Walk 1 Direction	To W		X Walk 2 Direction	To S
	X Walk 1 Width (in)	N/A		X Walk 2 Width (in)	N/A
	X Walk 1 Slope (%)	1.8		X Walk 2 Slope (%)	3.1
	X Walk 1 X Slope (%)	1.1		X Walk 2 X Slope (%)	1.5
N/A	Ramp inside XWalk1?	N/A	N/A	Ramp inside XWalk2?	N/A
	Road Slope (%)	1.5		Clear Space?	N/A
	Road X Slope (%)	1.8	N/A	Clear Space to XWalk (in)	N/A
			N/A	Any Obstruction?	N/A
				Obstruction Type	N/A
			N/A	Storm Grate/Utility Hazard?	N/A
				Storm Grate/Utility Type	N/A
			Yes	Surface Condition? (G/P)	Good
				Curb Slope (%)	13.4

**Remove & Replace Curb Ramp With Two New Directional Ramps or Equivalent.**
