# Access Compliance Report

## Public Rights-of-Way

### (Curb Ramps)

| Intersection ID: 6364 | Main Street: SONOMA_VALLEY_DR | Cross Street: RHYNE_RD | Location: | E |

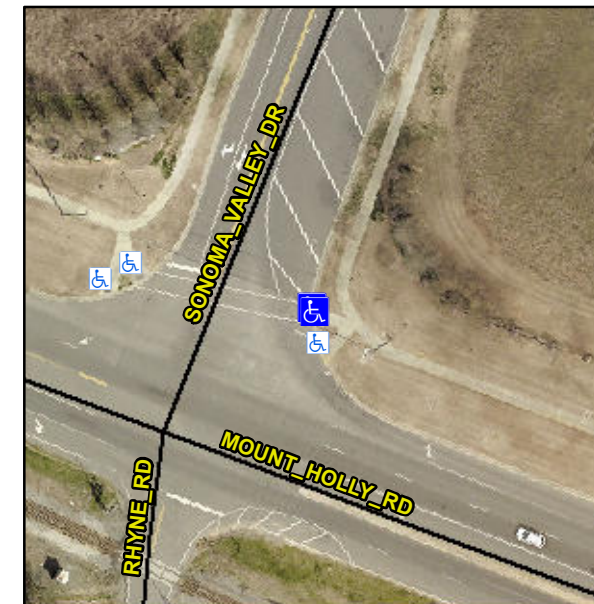
**Not Found, R304.2.2**

| Compliance | Description | Data | Compliance | Description | Data |
|---|---|---|---|---|---|
| N/A | Ramp Length (in) | 72.0 | No | Ramp Slope (%) | 9.1 |
| Yes | Ramp Width (in) | 58.0 | Yes | Ramp XSlope (%) | 0.9 |

**Remove & Replace Entire Ramp.**

Total Cost: \$ 1850.00
