Access Compliance Report

Public Rights-of-Way

(Curb Ramps)

Intersection ID: N/A	Main Street: COSTIGAN_LN	Cross Street: N/A	Location: S
ADA ID: BD3B2BE51608	Ramp Type: PerpDiag	Initial Pass/Fail: Fail	Overall Compliance: No
Severity Score: 21.25			
Codes/Mitigation Info/Possible Solution		Field Measurements/Component Compliance

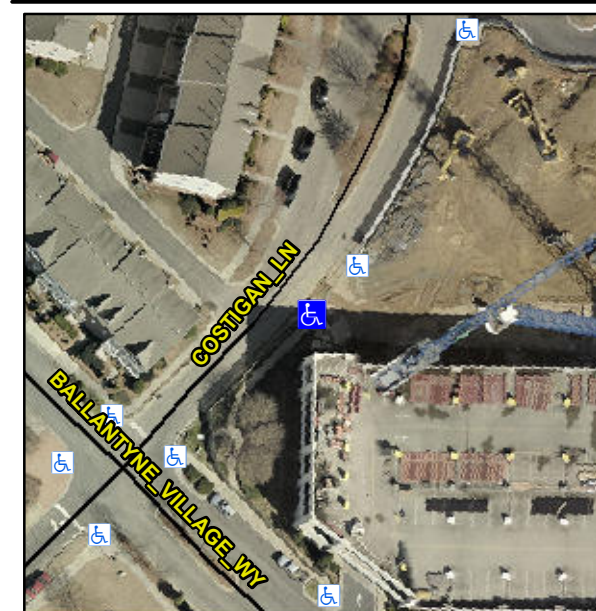
Not Found, R304.5.1, R304.5.3

Compliance	Description	Data	Compliance	Description	Data
N/A	Ramp Length (in)	74.0	Yes	Ramp Slope (%)	5.0
No	Ramp Width (in)	40.0	No	Ramp XSlope (%)	6.0
N/A	Flare Type LT	N/A	N/A	Flare Type RT	N/A
N/A	Flare Slope LT (%)	N/A	N/A	Flare Slope RT (%)	N/A
N/A	Flare Traversable LT?	N/A	N/A	Flare Traversable RT?	N/A
N/A	Landing Length (in)	N/A	N/A	DWS Provided?	N/A
N/A	Landing Width (in)	N/A	N/A	DWS Contrast?	N/A
N/A	Landing Slope (%)	N/A	N/A	DWS Length (in)	N/A
N/A	Landing X Slope (%)	N/A	N/A	DWS Full Width?	N/A
N/A	Landing Curb? (Y/N)	N/A	N/A	DWS Offset (in)	N/A
N/A	Shared Landing?	N/A			
N/A	Gutter Ponding?	N/A	N/A	Gutter Slope (%)	N/A
N/A	Gutter Lip Ht (in)	N/A	N/A	Gutter X Slope (%)	N/A
N/A	Painted X Walk1?	No	N/A	Painted X Walk2?	No
	X Walk 1 Direction	To NE		X Walk 2 Direction	To NW
N/A	X Walk 1 Width (in)	N/A	N/A	X Walk 2 Width (in)	N/A
	X Walk 1 Slope (%)	1.2		X Walk 2 Slope (%)	3.9
	X Walk 1 X Slope (%)	5.4		X Walk 2 X Slope (%)	1.7

N/A	Ramp inside XWalk1?	N/A	N/A	Ramp inside XWalk2?	N/A
	Road Slope (%)	3.7	N/A	Clear Space?	N/A
	Road X Slope (%)	1.2	N/A	Clear Space to XWalk (in)	N/A
N/A	Any Obstructions?	N/A	N/A	Storm Grate/Utility Hazard?	N/A
	Obstruction Type			Storm Grate/Utility Type	
		N/A			N/A
			Yes	Surface Condition? (G/P)	Good

Possible Solutions:

Remove & Replace Curb Ramp With Two New Directional Ramps or Equivalent.
