Access Compliance Report

Public Rights-of-Way

(Curb Ramps)

Intersection ID: 7759	Main Street: MONTANA_DR	Cross Street: KENDALL_DR	Location: SE
ADA ID: BD3B59B564BC	Ramp Type: Perp	Initial Pass/Fail: Fail	Overall Compliance: No
Severity Score: 33.75			
Codes/Mitigation Info/Possible Solution		Field Measurements/Component Compliance

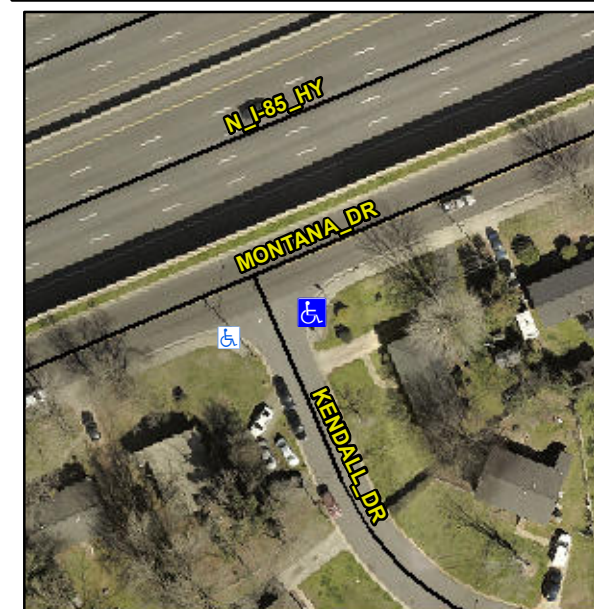
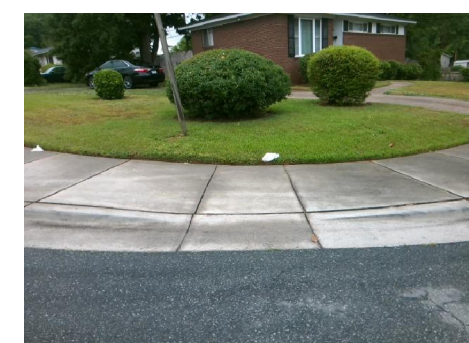
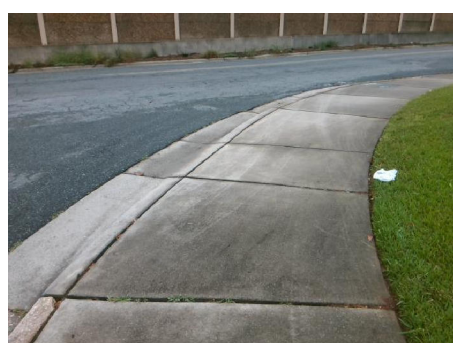
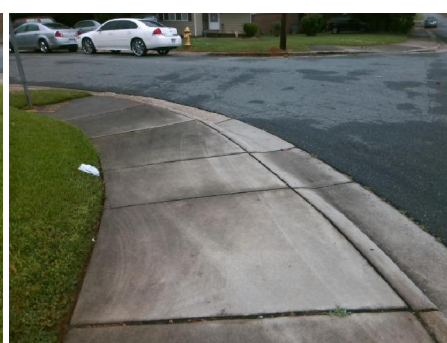
Not Found, R304.5.1, R304.5.3

Compliance	Description	Data	Compliance	Description	Data
N/A	Ramp Length (in)	71.0	Yes	Ramp Slope (%)	5.5
No	Ramp Width (in)	40.5	No	Ramp XSlope (%)	8.2
N/A	Flare Type LT	N/A	N/A	Flare Type RT	N/A
N/A	Flare Slope LT (%)	N/A	N/A	Flare Slope RT (%)	N/A
N/A	Flare Traversable LT?	N/A	N/A	Flare Traversable RT?	N/A
N/A	Landing Length (in)	N/A	N/A	DWS Provided?	N/A
N/A	Landing Width (in)	N/A	N/A	DWS Contrast?	N/A
N/A	Landing Slope (%)	N/A	N/A	DWS Length (in)	N/A
N/A	Landing X Slope (%)	N/A	N/A	DWS Full Width?	N/A
N/A	Landing Curb? (Y/N)	N/A	N/A	DWS Offset (in)	N/A
N/A	Shared Landing?	N/A			
N/A	Gutter Ponding?	N/A	N/A	Gutter Slope (%)	N/A
N/A	Gutter Lip Ht (in)	N/A	N/A	Gutter X Slope (%)	N/A
N/A	Painted X Walk1?	No	N/A	Painted X Walk2?	N/A
	X Walk 1 Direction	To W		X Walk 2 Direction	N/A
N/A	X Walk 1 Width (in)	N/A	N/A	X Walk 2 Width (in)	N/A
	X Walk 1 Slope (%)	1.3		X Walk 2 Slope (%)	N/A
	X Walk 1 X Slope (%)	5.3		X Walk 2 X Slope (%)	N/A

N/A	Ramp inside XWalk1?	N/A	N/A	Ramp inside XWalk2?	N/A
	Road Slope (%)	N/A	N/A	Clear Space?	N/A
	Road X Slope (%)	N/A	N/A	Clear Space to XWalk (in)	N/A
N/A	Any Obstructions?	N/A	N/A	Storm Grate/Utility Hazard?	N/A
	Obstruction Type			Storm Grate/Utility Type	
		N/A			N/A
			Yes	Surface Condition? (G/P)	Good

Possible Solutions:

Remove & Replace Entire Ramp.
