# Access Compliance Report

## Public Rights-of-Way

### (Curb Ramps)

Intersection ID: 4523	Main Street: FELDBANK_DR	Cross Street: TRINITY_RD	Location: NW
ADA ID: BD4434654BFD	Ramp Type: Perp	Initial Pass/Fail: Fail	Overall Compliance: No
Severity Score: 21.25			
Codes/Mitigation Info/Possible Solution		Field Measurements/Component Compliance

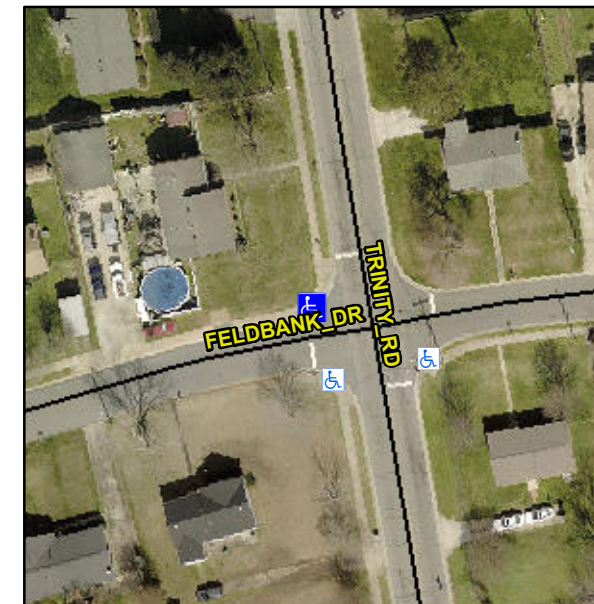
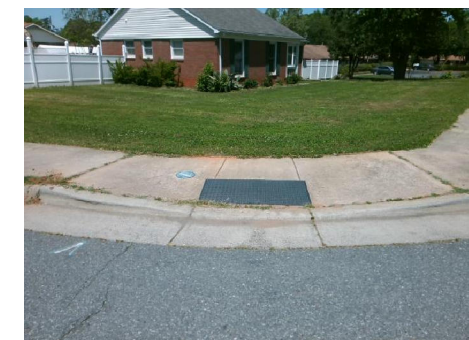
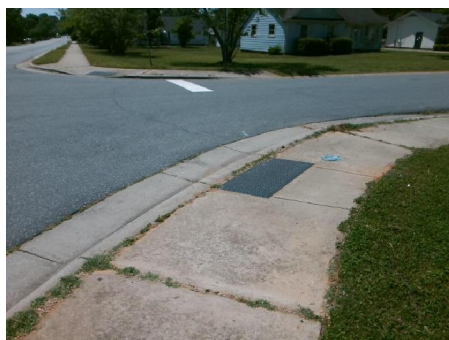
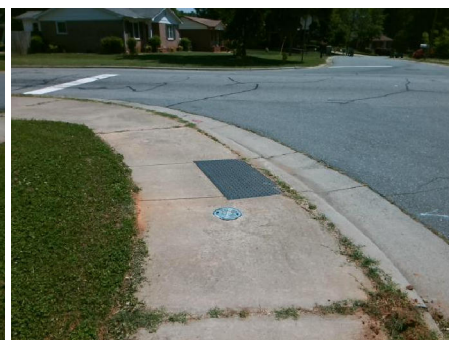
**R304.5.1, R304.2.2**

Compliance	Description	Data	Compliance	Description	Data
N/A	Ramp Length (in)	59.5	No	Ramp Slope (%)	8.5
No	Ramp Width (in)	37.0	Yes	Ramp XSlope (%)	0.9
N/A	Flare Type LT	N/A	N/A	Flare Type RT	N/A
N/A	Flare Slope LT (%)	N/A	N/A	Flare Slope RT (%)	N/A
N/A	Flare Traversable LT?	N/A	N/A	Flare Traversable RT?	N/A
N/A	Landing Length (in)	N/A	N/A	DWS Provided?	N/A
N/A	Landing Width (in)	N/A	N/A	DWS Contrast?	N/A
N/A	Landing Slope (%)	N/A	N/A	DWS Length (in)	N/A
N/A	Landing X Slope (%)	N/A	N/A	DWS Full Width?	N/A
N/A	Landing Curb? (Y/N)	N/A	N/A	DWS Offset (in)	N/A
N/A	Shared Landing?	N/A			
N/A	Gutter Ponding?	N/A	N/A	Gutter Slope (%)	N/A
N/A	Gutter Lip Ht (in)	1.5	N/A	Gutter X Slope (%)	N/A
N/A	Painted X Walk1?	No	N/A	Painted X Walk2?	N/A
	X Walk 1 Direction	To S		X Walk 2 Direction	N/A
N/A	X Walk 1 Width (in)	N/A	N/A	X Walk 2 Width (in)	N/A
	X Walk 1 Slope (%)	1.0		X Walk 2 Slope (%)	N/A
	X Walk 1 X Slope (%)	0.6		X Walk 2 X Slope (%)	N/A

N/A	Ramp inside XWalk1?	N/A	N/A	Ramp inside XWalk2?	N/A
	Road Slope (%)	N/A	N/A	Clear Space?	N/A
	Road X Slope (%)	N/A	N/A	Clear Space to XWalk (in)	N/A
N/A	Any Obstructions?	N/A	N/A	Storm Grate/Utility Hazard?	N/A
	Obstruction Type			Storm Grate/Utility Type	
		N/A			N/A
			Yes	Surface Condition? (G/P)	Good

**Remove & Replace Entire Ramp.**

Total Cost: \$ 1850.00
