Access Compliance Report Public Rights-of-Way (Curb Ramps)

Intersection ID: 10029218 Main Street: JOHNSON_AND_WALES_WY Cross Street: N/A Location: W

ADA ID: BD485364ED85 Ramp Type: Perp Initial Pass/Fail: Fail Overall Compliance: No Severity Score: 12.5

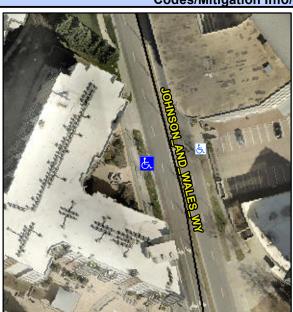
Comn	liance Description	Doto	Comr	lionos	Description	Data
	liance Description	Data			Description	
N/A	Ramp Length (in)	96.5	Yes		Slope (%)	7.3
Yes	Ramp Width (in)	71.0	No	Ramp	XSlope (%)	6.4
N/A	Flare Type LT	N/A	N/A	Flare	Type RT	N/A
N/A	Flare Slope LT (%)	N/A	N/A	Flare	Slope RT (%)	N/A
N/A	Flare Traversable LT?	N/A	N/A	Flare	Traversable RT?	N/A
N/A	Landing Length (in)	N/A	N/A	DWS	Provided?	N/A
N/A	Landing Width (in)	N/A	N/A	DWS	Contrast?	N/A
N/A	Landing Slope (%)	N/A	N/A	DWS	Length (in)	N/A
N/A	Landing X Slope (%)	N/A	N/A	DWS	Full Width?	N/A
N/A	Landing Curb? (Y/N)	N/A	N/A	DWS	Offset (in)	N/A
N/A	Shared Landing?	N/A				
N/A	Gutter Ponding?	N/A	N/A	Gutte	r Slope (%)	N/A
N/A	Gutter Lip Ht (in)	N/A	N/A	Gutte	r X Slope (%)	N/A
N/A	Painted X Walk1?	No	N/A	Paint	ed X Walk2?	N/A
	X Walk 1 Direction	То Е		X Wa	lk 2 Direction	N/A
N/A	X Walk 1 Width (in)	N/A	N/A	X Wa	lk 2 Width (in)	N/A
	X Walk 1 Slope (%)	4.4		X Wa	lk 2 Slope (%)	N/A

X Walk 1 X Slope (%)	3.2		X Wa	lk 2 X Slope (%)	N/A
N/A	Ramp inside XWalk1?	N/A	N/A	Ram	inside XWalk2?	N/A
	Road Slope (%)	N/A	N/A	Clear	Space?	N/A
	Road X Slope (%)	N/A	N/A	Clear	Space to XWalk (in)	N/A
N/A	Any Obstructions?	N/A	N/A	Storn	n Grate/Utility Hazard?	N/A
	Obstruction Type			Storn	n Grate/Utility Type	
		N/A				N/A
			Yes	Surfa	ce Condition? (G/P)	Good

Possible Solutions:					
Remove & Replace Entire Ramp.					
·					
	ļ				
Surveyor Notes:					
N/A					
PROW/ADA:					
Not Found, R304.5.3	ı
