# Access Compliance Report

## Public Rights-of-Way

### (Curb Ramps)

| Intersection ID: 5899 | Main Street: CORA_ST | Cross Street: OAK_DR | Location: NW |

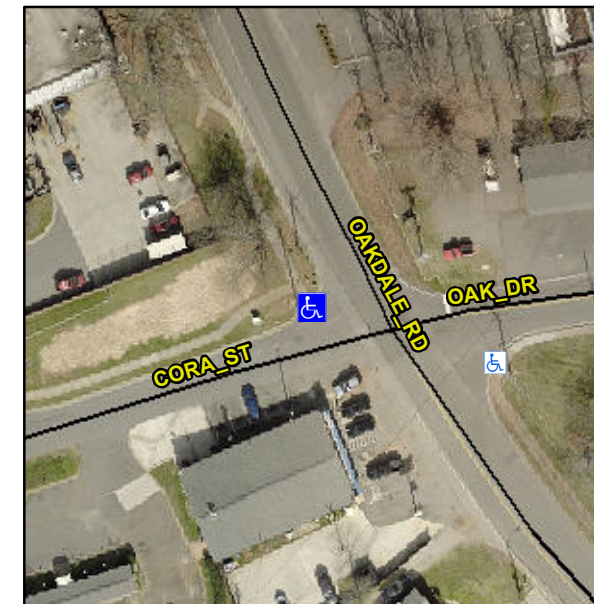
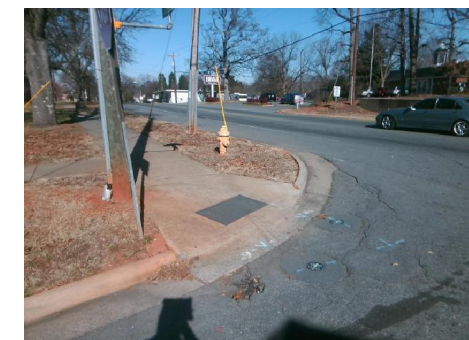
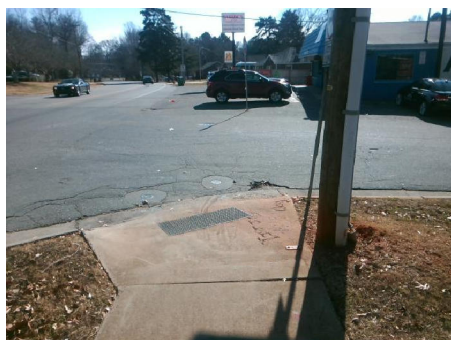
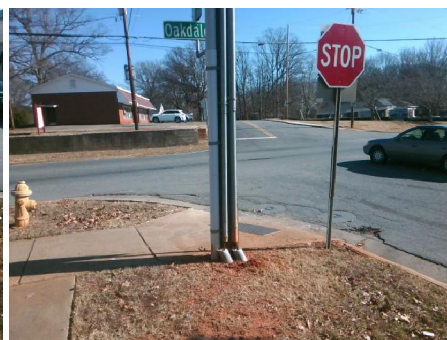
| ADA ID: BD5206F00143 | Ramp Type: Perp | Initial Pass/Fail: Fail | Overall Compliance: No |

| | | Severity Score: 12.5 | |

**Not Found, R304.2.2**

| Compliance | Description | Data | Compliance | Description | Data |
|---|---|---|---|---|---|
| N/A | Ramp Length (in) | 90.0 | No | Ramp Slope (%) | 11.6 |

**Remove & Replace Entire Ramp.**

Total Cost: \$ 1850.00
