Access Compliance Report

Public Rights-of-Way

(Curb Ramps)

Intersection ID: N/A	Main Street: E_STONEWALL_ST	Cross Street: S_DAVIDSON_ST	Location: N
ADA ID: BD55E8991196	Ramp Type: Combination1	Initial Pass/Fail: Fail	Overall Compliance: No
			Severity Score: 13.75

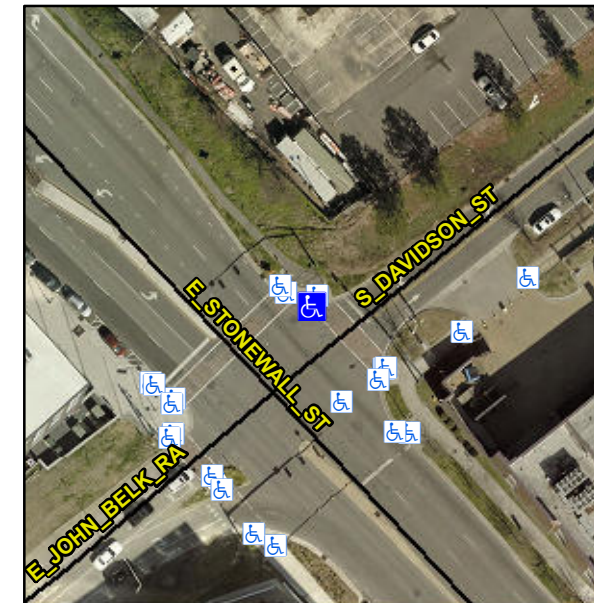
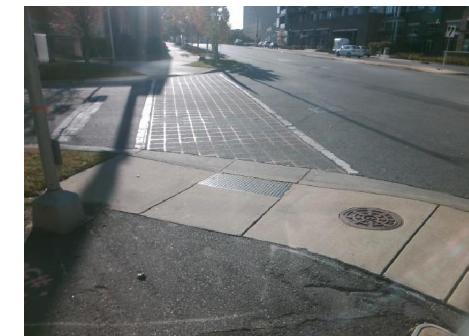
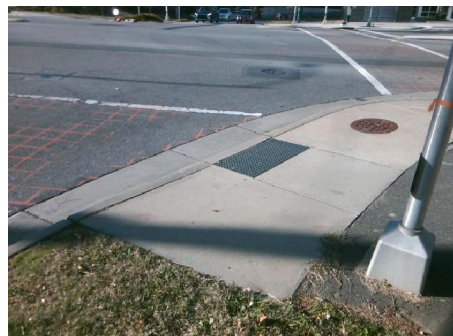
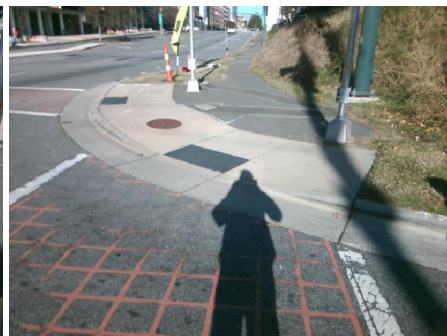
Not Found, R304.3.2, R304.5.3

Compliance	Description	Data	Compliance	Description	Data
N/A	Ramp Length LT (in)	55.5	N/A	Ramp Length RT (in)	61.0
Yes	Ramp Width LT (in)	73.0	Yes	Ramp Width RT (in)	72.0
No	Ramp Slope LT (%)	11.3	Yes	Ramp Slope RT (%)	5.2
No	Ramp XSlope LT (%)	3.1	No	Ramp XSlope RT (%)	4.2
N/A	Ramp Length (in)	24.5	Yes	Ramp Slope (%)	5.9
Yes	Ramp Width (in)	48.0	Yes	Ramp XSlope (%)	1.2
N/A	Flare Type LT	N/A	N/A	Flare Type RT	N/A
N/A	Flare Slope LT (%)	N/A	N/A	Flare Slope RT (%)	N/A
N/A	Flare Traversable LT?	N/A	N/A	Flare Traversable RT?	N/A
N/A	Landing Length (in)	N/A	N/A	DWS Provided?	N/A
N/A	Landing Width (in)	N/A	N/A	DWS Contrast?	N/A
N/A	Landing Slope (%)	N/A	N/A	DWS Length (in)	N/A
N/A	Landing X Slope (%)	N/A	N/A	DWS Full Width?	N/A
N/A	Landing Curb? (Y/N)	N/A	N/A	DWS Offset (in)	N/A
N/A	Shared Landing?	N/A			
N/A	Gutter Ponding?	N/A	N/A	Gutter Slope (%)	N/A
N/A	Gutter Lip Ht (in)	N/A	N/A	Gutter X Slope (%)	N/A
N/A	Painted X Walk1?	Yes	N/A	Painted X Walk2?	N/A

X Walk 1 Direction	To SE		X Walk 2 Direction	N/A
	X Walk 1 Width (in)	125.0		X Walk 2 Width (in)	N/A
	X Walk 1 Slope (%)	1.9		X Walk 2 Slope (%)	N/A
	X Walk 1 X Slope (%)	2.1		X Walk 2 X Slope (%)	N/A
N/A	Ramp inside XWalk1?	Yes	N/A	Ramp inside XWalk2?	N/A
	Road Slope (%)	N/A		Clear Space?	N/A
	Road X Slope (%)	N/A	N/A	Clear Space to XWalk (in)	N/A
			N/A	Any Obstruction?	N/A
				Obstruction Type	N/A
			N/A	Storm Grate/Utility Hazard?	N/A
				Storm Grate/Utility Type	N/A
Yes	Surface Condition? (G/P)	Good			
	Curb Slope (%)	6.8

Remove & Replace Entire Ramp.

\$ 1800.00
