## Access Compliance Report Public Rights-of-Way (Curb Ramps)

Intersection ID: 50619Main Street:COTTON\_GUM\_RDCross Street:YELLOW\_OAK\_RDLocation:NEADA ID: BD58235F8EADRamp Type:PerpInitial Pass/Fail:FailOverall Compliance:NoSeverity Score:26.25

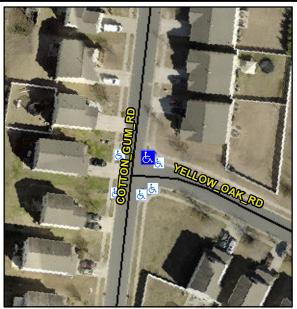
F. 11.14						
Field Measurements/Component Compliance						
Compliance Description		Data	Data Compliance Description		Data	
N/A	Ramp Length (in)	46.5	No	Ramp Slope (%)	18.4	
Yes	Ramp Width (in)	48.0	No	Ramp XSlope (%)	2.8	
N/A	Flare Type LT	N/A	N/A	Flare Type RT	N/A	
N/A	Flare Slope LT (%)	N/A	N/A	Flare Slope RT (%)	N/A	
N/A	Flare Traversable LT?	N/A	N/A	Flare Traversable RT?	N/A	
N/A	Landing Length (in)	N/A	N/A	DWS Provided?	N/A	
N/A	Landing Width (in)	N/A	N/A	DWS Contrast?	N/A	
N/A	Landing Slope (%)	N/A	N/A	DWS Length (in)	N/A	
N/A	Landing X Slope (%)	N/A	N/A	DWS Full Width?	N/A	
N/A	Landing Curb? (Y/N)	N/A	N/A	DWS Offset (in)	N/A	
N/A	Shared Landing?	N/A				
N/A	Gutter Ponding?	N/A	N/A	Gutter Slope (%)	N/A	
N/A	Gutter Lip Ht (in)	N/A	N/A	Gutter X Slope (%)	N/A	
N/A	Painted X Walk1?	No	N/A	Painted X Walk2?	N/A	
	X Walk 1 Direction	To W		X Walk 2 Direction	N/A	
N/A	X Walk 1 Width (in)	N/A	N/A	X Walk 2 Width (in)	N/A

X Walk 1 Slope (%)	5.0		X Walk 2 Slope (%)	N/A	
	X Walk 1 X Slope (%)	0.5		X Walk 2 X Slope (%)	N/A	
N/A	Ramp inside XWalk1?	N/A	N/A	Ramp inside XWalk2?	N/A	
	Road Slope (%)	N/A	N/A	Clear Space?	N/A	
	Road X Slope (%)	N/A	N/A	Clear Space to XWalk (in)	N/A	
N/A	Any Obstructions?	N/A	N/A	Storm Grate/Utility Hazard?	N/A	
	Obstruction Type			Storm Grate/Utility Type		
		N/A			N/A	
			Yes	Surface Condition? (G/P)	Good

Possible Solutions:						
Remove & Replace Entire Ramp.						
Surveyor Notes:						
N/A						
PROW/ADA:						
Not Found, R304.2.2, R304.5.3
