Access Compliance Report

Public Rights-of-Way

(Curb Ramps)

Intersection ID: 5813	Main Street: MALLARD_CREEK_RD	Cross Street: MALLARD_SQUARE_LN	Location: W
ADA ID: BD584DC64C33	Ramp Type: PerpDiag	Initial Pass/Fail: Fail	Overall Compliance: No
Codes/Mitigation Info/Possible Solution		Field Measurements/Component Compliance	
Severity Score: 8.75

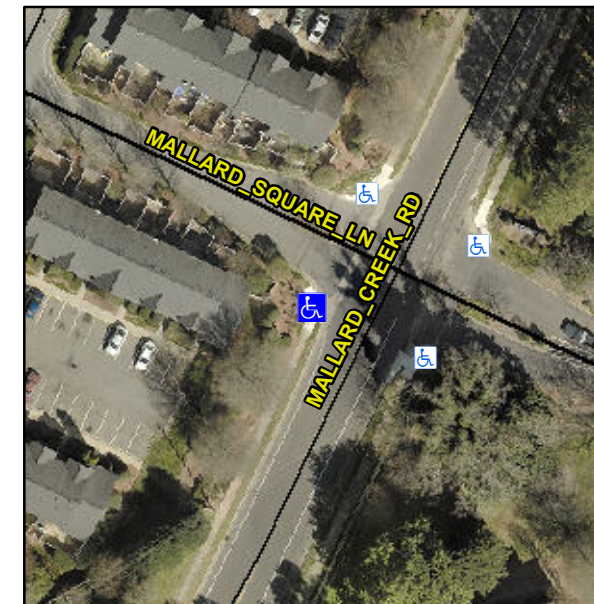
Compliance	Description	Data	Compliance	Description	Data
N/A	Ramp Length (in)	80.0	Yes	Ramp Slope (%)	7.4
No	Ramp Width (in)	47.5	Yes	Ramp XSlope (%)	1.6
N/A	Flare Type LT	N/A	N/A	Flare Type RT	N/A
N/A	Flare Slope LT (%)	N/A	N/A	Flare Slope RT (%)	N/A
N/A	Flare Traversable LT?	N/A	N/A	Flare Traversable RT?	N/A
N/A	Landing Length (in)	N/A	N/A	DWS Provided?	N/A
N/A	Landing Width (in)	N/A	N/A	DWS Contrast?	N/A
N/A	Landing Slope (%)	N/A	N/A	DWS Length (in)	N/A
N/A	Landing X Slope (%)	N/A	N/A	DWS Full Width?	N/A
N/A	Landing Curb? (Y/N)	N/A	N/A	DWS Offset (in)	N/A
N/A	Shared Landing?	N/A			
N/A	Gutter Ponding?	N/A	N/A	Gutter Slope (%)	N/A
N/A	Gutter Lip Ht (in)	N/A	N/A	Gutter X Slope (%)	N/A
N/A	Painted X Walk1?	No	N/A	Painted X Walk2?	No
	X Walk 1 Direction	To NE		X Walk 2 Direction	To SE
N/A	X Walk 1 Width (in)	N/A	N/A	X Walk 2 Width (in)	N/A
	X Walk 1 Slope (%)	0.1		X Walk 2 Slope (%)	2.6
	X Walk 1 X Slope (%)	0.2		X Walk 2 X Slope (%)	0.9

N/A	Ramp inside XWalk1?	N/A	N/A	Ramp inside XWalk2?	N/A
	Road Slope (%)	0.8	N/A	Clear Space?	N/A
	Road X Slope (%)	2.6	N/A	Clear Space to XWalk (in)	N/A
N/A	Any Obstructions?	N/A	N/A	Storm Grate/Utility Hazard?	N/A
	Obstruction Type			Storm Grate/Utility Type	
		N/A			N/A
			Yes	Surface Condition? (G/P)	Good

Possible Solutions:

Remove & Replace Curb Ramp With Two New Directional Ramps or Equivalent.

Not Found, R304.5.1

Total Cost: \$ 3200.00
