Access Compliance Report

Public Rights-of-Way

(Curb Ramps)

Intersection ID: 10041415	Main Street: WESTHALL_DR	Cross Street: N/A	Location: SE
ADA ID: BD5F69E142F9	Ramp Type: PerpDiag	Initial Pass/Fail: Fail	Overall Compliance: No
Codes/Mitigation Info/Possible Solution		Field Measurements/Component Compliance	
Severity Score: 12.5

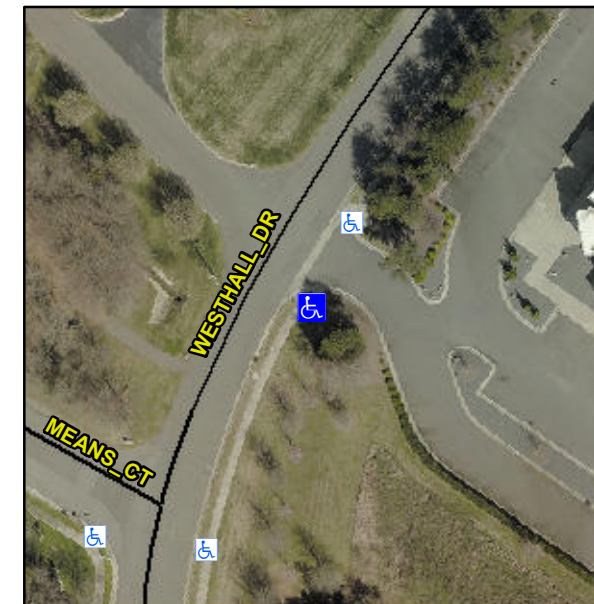
Not Found, R304.2.2

Compliance	Description	Data	Compliance	Description	Data
N/A	Ramp Length (in)	108.0	No	Ramp Slope (%)	9.2
Yes	Ramp Width (in)	48.0	Yes	Ramp XSlope (%)	0.1
N/A	Flare Type LT	N/A	N/A	Flare Type RT	N/A
N/A	Flare Slope LT (%)	N/A	N/A	Flare Slope RT (%)	N/A
N/A	Flare Traversable LT?	N/A	N/A	Flare Traversable RT?	N/A
N/A	Landing Length (in)	N/A	N/A	DWS Provided?	N/A
N/A	Landing Width (in)	N/A	N/A	DWS Contrast?	N/A
N/A	Landing Slope (%)	N/A	N/A	DWS Length (in)	N/A
N/A	Landing X Slope (%)	N/A	N/A	DWS Full Width?	N/A
N/A	Landing Curb? (Y/N)	N/A	N/A	DWS Offset (in)	N/A
N/A	Shared Landing?	N/A			
N/A	Gutter Ponding?	N/A	N/A	Gutter Slope (%)	N/A
N/A	Gutter Lip Ht (in)	N/A	N/A	Gutter X Slope (%)	N/A
N/A	Painted X Walk1?	No	N/A	Painted X Walk2?	No
	X Walk 1 Direction	To NE		X Walk 2 Direction	To NW
N/A	X Walk 1 Width (in)	N/A	N/A	X Walk 2 Width (in)	N/A
	X Walk 1 Slope (%)	4.3		X Walk 2 Slope (%)	3.4
	X Walk 1 X Slope (%)	5.6		X Walk 2 X Slope (%)	1.8

N/A	Ramp inside XWalk1?	N/A	N/A	Ramp inside XWalk2?	N/A
	Road Slope (%)	2.1	N/A	Clear Space?	N/A
	Road X Slope (%)	3.5	N/A	Clear Space to XWalk (in)	N/A
N/A	Any Obstructions?	N/A	N/A	Storm Grate/Utility Hazard?	N/A
	Obstruction Type			Storm Grate/Utility Type	
		N/A			N/A
			Yes	Surface Condition? (G/P)	Good

Remove & Replace Curb Ramp With Two New Directional Ramps or Equivalent.
