# Access Compliance Report

## Public Rights-of-Way

### (Curb Ramps)

Intersection ID: 12646	Main Street: LEVINE AVENUE OF THE ARTS	Cross Street: S TRYON ST	Location: S
ADA ID: BD81C05E9BC3	Ramp Type: PerpDiag	Initial Pass/Fail: Fail	Overall Compliance: No
		Severity Score: 25

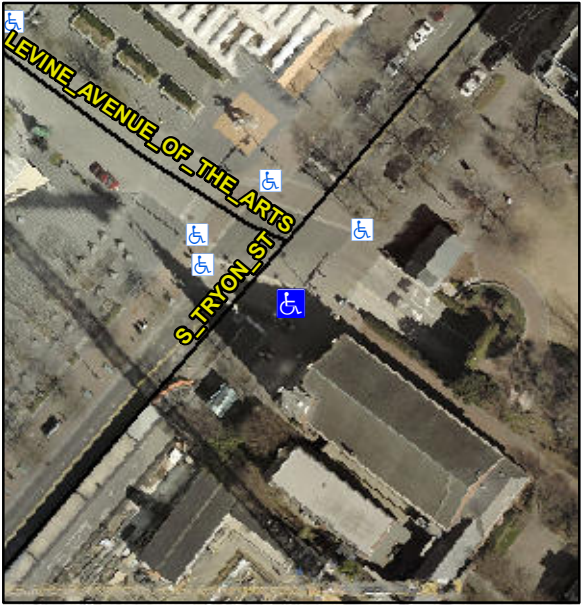
Possible Solutions:		<b>Compliance</b>	<b>Description</b>	<b>Data</b>
	<b>Remove &amp; Replace Curb Ramp With Two New Directional Ramps or Equivalent.</b>		<b>No</b>	Ramp Length (in)	53.0
			<b>Yes</b>	Ramp Width (in)	163.0
			<b>N/A</b>	Flare Type LT	N/A
			<b>N/A</b>	Flare Slope LT (%)	N/A
			<b>N/A</b>	Flare Traversable LT?	N/A
			<b>N/A</b>	Landing Length (in)	N/A
			<b>N/A</b>	Landing Width (in)	N/A
			<b>N/A</b>	Landing Slope (%)	N/A
			<b>N/A</b>	Landing X Slope (%)	N/A
<p>Surveyor Notes:</p> <p><b>N/A</b></p> <p>PROW/ADA:</p> <p><b>R304.2.2, R304.5.3</b></p>			<b>N/A</b>	Flare Type RT	N/A
			<b>N/A</b>	Flare Slope RT (%)	N/A
			<b>N/A</b>	Flare Traversable RT?	N/A
			<b>N/A</b>	DWS Provided?	N/A
			<b>N/A</b>	DWS Contrast?	N/A
			<b>N/A</b>	DWS Length (in)	N/A
			<b>N/A</b>	DWS Full Width?	N/A
			<b>N/A</b>	DWS Offset (in)	N/A

<b>N/A</b>	Gutter Ponding?	N/A
			<b>N/A</b>	Gutter Lip Ht (in)	N/A
			<b>No</b>	Painted X Walk1?	Yes
				X Walk 1 Direction	To NE
			<b>N/A</b>	X Walk 1 Width (in)	N/A
				X Walk 1 Slope (%)	1.1
				X Walk 1 X Slope (%)	3.8
			<b>N/A</b>	Ramp inside XWalk1?	N/A
				Road Slope (%)	0.7
				Road X Slope (%)	4.4
			<b>N/A</b>	Any Obstructions?	N/A
				Obstruction Type	
Total Cost:		\$ 3200.00	<b>N/A</b>		N/A
			<b>Yes</b>	Surface Condition? (G/P)	Good
