Access Compliance Report

Public Rights-of-Way

(Curb Ramps)

Intersection ID: 31171	Main Street: POINTER_RD	Cross Street: BROWNE_RD	Location: NW
ADA ID: BD8472822641	Ramp Type: Perp	Initial Pass/Fail: Fail	Overall Compliance: No
Severity Score: 10			
Codes/Mitigation Info/Possible Solution		Field Measurements/Component Compliance

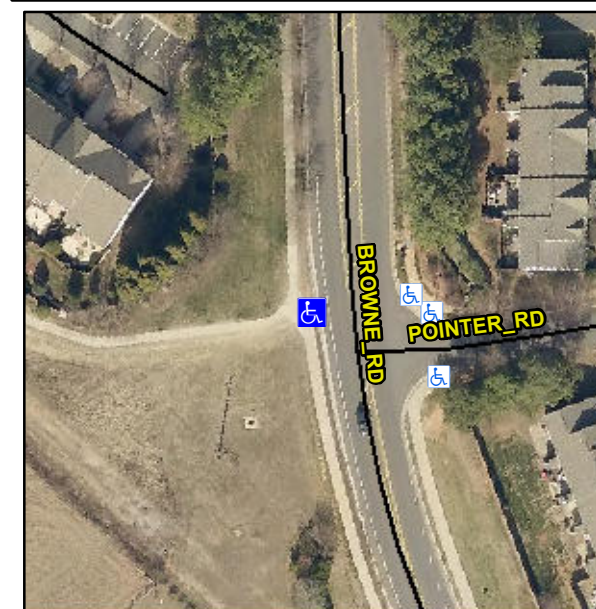
R304.5.1, R304.5.3

Compliance	Description	Data	Compliance	Description	Data
N/A	Ramp Length (in)	84.0	Yes	Ramp Slope (%)	5.8
No	Ramp Width (in)	47.5	No	Ramp XSlope (%)	2.9
N/A	Flare Type LT	N/A	N/A	Flare Type RT	N/A
N/A	Flare Slope LT (%)	N/A	N/A	Flare Slope RT (%)	N/A
N/A	Flare Traversable LT?	N/A	N/A	Flare Traversable RT?	N/A
N/A	Landing Length (in)	N/A	N/A	DWS Provided?	N/A
N/A	Landing Width (in)	N/A	N/A	DWS Contrast?	N/A
N/A	Landing Slope (%)	N/A	N/A	DWS Length (in)	N/A
N/A	Landing X Slope (%)	N/A	N/A	DWS Full Width?	N/A
N/A	Landing Curb? (Y/N)	N/A	N/A	DWS Offset (in)	N/A
N/A	Shared Landing?	N/A			
N/A	Gutter Ponding?	N/A	N/A	Gutter Slope (%)	N/A
N/A	Gutter Lip Ht (in)	N/A	N/A	Gutter X Slope (%)	N/A
N/A	Painted X Walk1?	No	N/A	Painted X Walk2?	N/A
	X Walk 1 Direction	To E		X Walk 2 Direction	N/A
N/A	X Walk 1 Width (in)	N/A	N/A	X Walk 2 Width (in)	N/A
	X Walk 1 Slope (%)	4.0		X Walk 2 Slope (%)	N/A
	X Walk 1 X Slope (%)	2.5		X Walk 2 X Slope (%)	N/A

N/A	Ramp inside XWalk1?	N/A	N/A	Ramp inside XWalk2?	N/A
	Road Slope (%)	N/A	N/A	Clear Space?	N/A
	Road X Slope (%)	N/A	N/A	Clear Space to XWalk (in)	N/A
N/A	Any Obstructions?	N/A	N/A	Storm Grate/Utility Hazard?	N/A
	Obstruction Type			Storm Grate/Utility Type	
		N/A			N/A
			Yes	Surface Condition? (G/P)	Good

Remove & Replace Entire Ramp.

Total Cost: \$ 1850.00
