Access Compliance Report

Public Rights-of-Way

(Curb Ramps)

Intersection ID: 26345	Main Street: BEAUCATCHER_LN	Cross Street: RHETT_BUTLER_PL	Location: SE
ADA ID: BD87E397AADE	Ramp Type: BlendTrans1	Initial Pass/Fail: Fail	Overall Compliance: No
Severity Score: 35			
Codes/Mitigation Info/Possible Solution		Field Measurements/Component Compliance

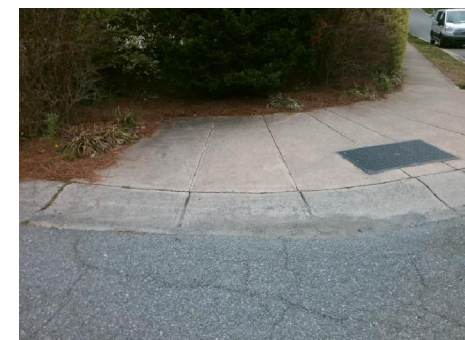
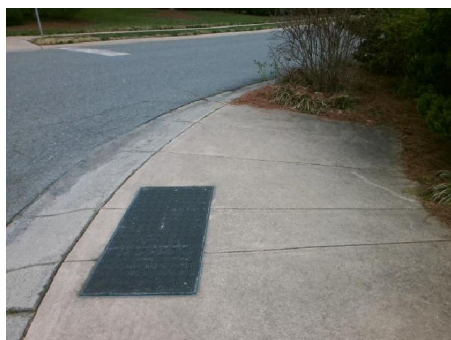
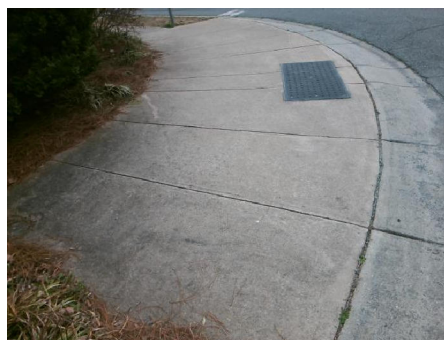
DWS MISPLACED

Not Found, R304.5.1

Compliance	Description	Data	Compliance	Description	Data
N/A	Ramp Length (in)	96.0	Yes	BlendTrans Slope (%)	2.1
No	Ramp Width (in)	28.0	Yes	BlendTrans XSlope (%)	1.3
N/A	Flare Type LT	N/A	N/A	Flare Type RT	N/A
N/A	Flare Slope LT (%)	N/A	N/A	Flare Slope RT (%)	N/A
N/A	Flare Traversable LT?	N/A	N/A	Flare Traversable RT?	N/A
N/A	Landing Length (in)	N/A	N/A	DWS Provided?	N/A
N/A	Landing Width (in)	N/A	N/A	DWS Contrast?	N/A
N/A	Landing Slope (%)	N/A	N/A	DWS Length (in)	N/A
N/A	Landing X Slope (%)	N/A	N/A	DWS Full Width?	N/A
N/A	Landing Curb? (Y/N)	N/A	N/A	DWS Offset (in)	N/A
N/A	Shared Landing?	N/A			
N/A	Gutter Ponding?	N/A	N/A	Gutter Slope (%)	N/A
N/A	Gutter Lip Ht (in)	N/A	N/A	Gutter X Slope (%)	N/A
N/A	Painted X Walk1?	No	N/A	Painted X Walk2?	N/A
	X Walk 1 Direction	To NW		X Walk 2 Direction	N/A
	X Walk 1 Width (in)	N/A		X Walk 2 Width (in)	N/A
	X Walk 1 Slope (%)	4.2		X Walk 2 Slope (%)	N/A
	X Walk 1 X Slope (%)	3.3		X Walk 2 X Slope (%)	N/A

N/A	Ramp inside XWalk1?	N/A	N/A	Ramp inside XWalk2?	N/A
	Road Slope (%)	3.3		Clear Space?	N/A
	Road X Slope (%)	4.2	N/A	Clear Space to XWalk (in)	N/A
N/A	Any Obstructions?	N/A	N/A	Storm Grate/Utility Hazard?	N/A
	Obstruction Type			Storm Grate/Utility Type	
		N/A			N/A
			Yes	Surface Condition? (G/P)	Good
			No	Curb Slope (%)	10.3

Remove & Replace Curb Ramp With Two New Directional Ramps or Equivalent.
