# Access Compliance Report

## Public Rights-of-Way

### (Curb Ramps)

| Intersection ID: 8700 | Main Street: L_D PARKER DR | Cross Street: HOLLAND AV | Location: SW |

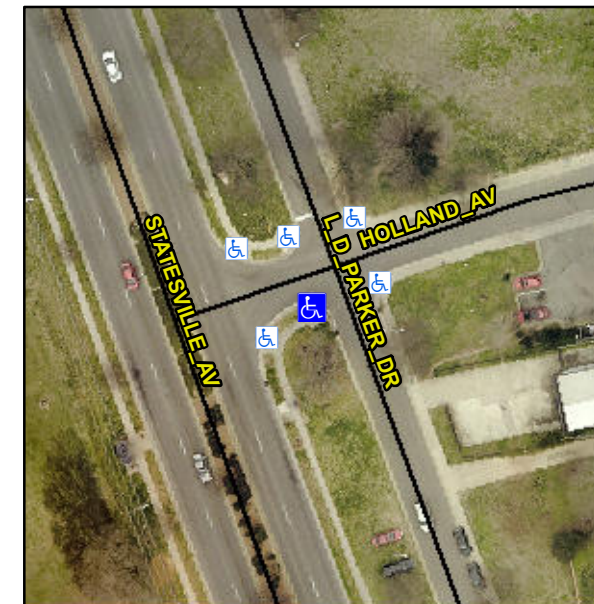
| ADA ID: BD95103FE53A | Ramp Type: PerpDiag | Initial Pass/Fail: Fail | Overall Compliance: No |

**R304.5.1, R304.2.2**

| Compliance | Description | Data | Compliance | Description | Data |
|---|---|---|---|---|---|
| N/A | Ramp Length (in) | 63.0 | No | Ramp Slope (%) | 9.6 |
| No | Ramp Width (in) | 29.0 | Yes | Ramp XSlope (%) | 1.1 |

**Remove & Replace Curb Ramp With Two New Directional Ramps or Equivalent.**

Total Cost: \$ 3200.00
