Access Compliance Report

Public Rights-of-Way

(Curb Ramps)

Intersection ID: 3919	Main Street: MOUNTAIN_PARK_DR	Cross Street: MT_ISLE_HARBOR_DR	Location: NE
ADA ID: BD96BAF14E99	Ramp Type: Perp	Initial Pass/Fail: Fail	Overall Compliance: No
			Severity Score: 10

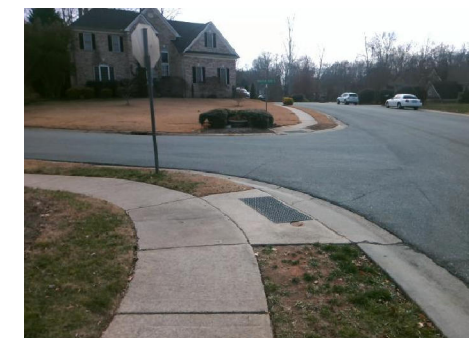
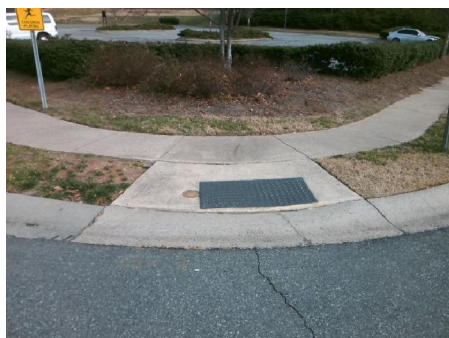
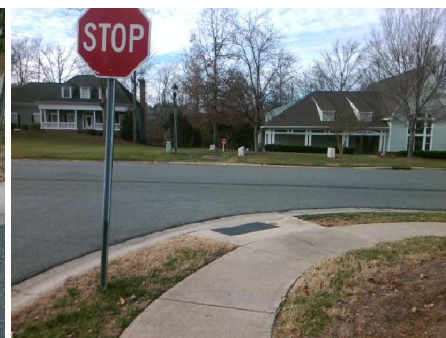
Not Found, R304.5.1, R304.5.3

Compliance	Description	Data	Compliance	Description	Data
N/A	Ramp Length (in)	47.0	Yes	Ramp Slope (%)	7.8
No	Ramp Width (in)	47.5	No	Ramp XSlope (%)	2.9
N/A	Flare Type LT	N/A	N/A	Flare Type RT	N/A
N/A	Flare Slope LT (%)	N/A	N/A	Flare Slope RT (%)	N/A
N/A	Flare Traversable LT?	N/A	N/A	Flare Traversable RT?	N/A
N/A	Landing Length (in)	N/A	N/A	DWS Provided?	N/A
N/A	Landing Width (in)	N/A	N/A	DWS Contrast?	N/A
N/A	Landing Slope (%)	N/A	N/A	DWS Length (in)	N/A
N/A	Landing X Slope (%)	N/A	N/A	DWS Full Width?	N/A
N/A	Landing Curb? (Y/N)	N/A	N/A	DWS Offset (in)	N/A
N/A	Shared Landing?	N/A			
N/A	Gutter Ponding?	N/A	N/A	Gutter Slope (%)	N/A
N/A	Gutter Lip Ht (in)	N/A	N/A	Gutter X Slope (%)	N/A
N/A	Painted X Walk1?	No	N/A	Painted X Walk2?	N/A
	X Walk 1 Direction	To S		X Walk 2 Direction	N/A
N/A	X Walk 1 Width (in)	N/A	N/A	X Walk 2 Width (in)	N/A
	X Walk 1 Slope (%)	2.6		X Walk 2 Slope (%)	N/A
	X Walk 1 X Slope (%)	1.1		X Walk 2 X Slope (%)	N/A

Remove & Replace Entire Ramp.
