Access Compliance Report

Public Rights-of-Way

(Curb Ramps)

Intersection ID: 13745	Main Street: HAWTHORNE_LN	Cross Street: PARK_DR	Location:	E
ADA ID: BD9A70B2B187	Ramp Type: BlendTrans1	Initial Pass/Fail: Pass	Overall Compliance: No	Severity Score: 0.25

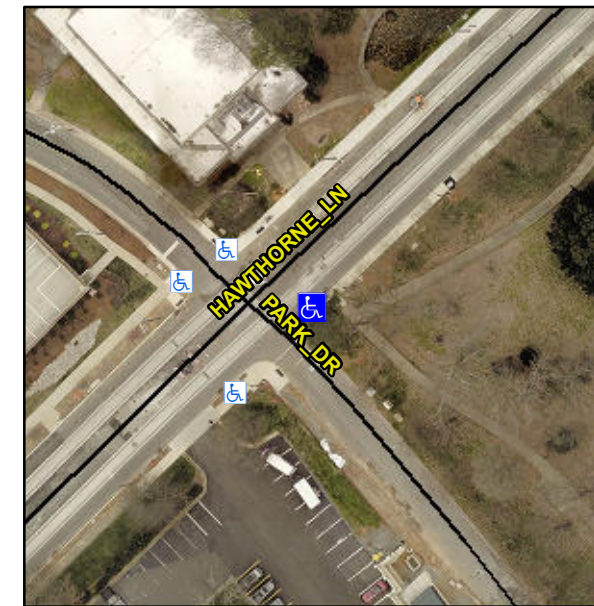
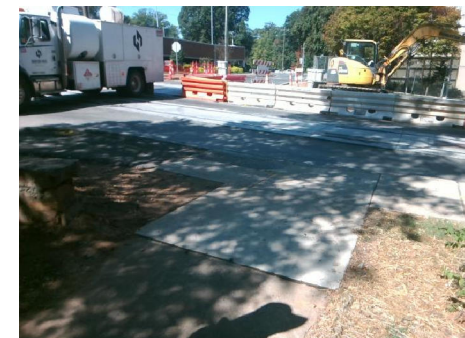
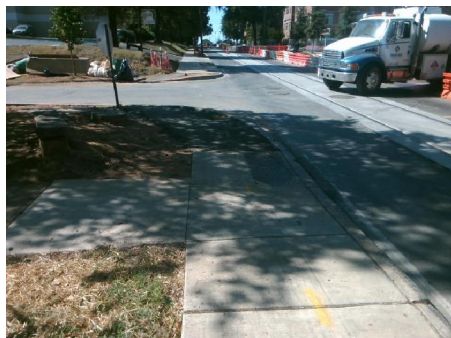
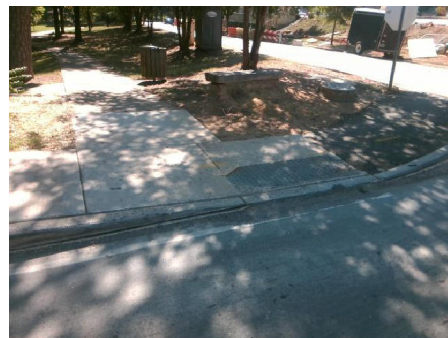
LNDG OS FROM RAMP

Compliance	Description	Data	Compliance	Description	Data
N/A	Ramp Length (in)	59.0	Yes	BlendTrans Slope (%)	1.7
Yes	Ramp Width (in)	63.0	Yes	BlendTrans XSlope (%)	3.5
N/A	Flare Type LT	Sloped	N/A	Flare Type RT	None
Yes	Flare Slope LT (%)	0.7	N/A	Flare Slope RT (%)	N/A
N/A	Flare Traversable LT?	Yes	N/A	Flare Traversable RT?	N/A
Yes	Landing Length (in)	67.0	Yes	DWS Provided?	Yes
Yes	Landing Width (in)	72.5	Yes	DWS Contrast?	Yes
Yes	Landing Slope (%)	1.2	Yes	DWS Length (in)	24.0
Yes	Landing X Slope (%)	0.3	Yes	DWS Full Width?	Yes
N/A	Landing Curb? (Y/N)	No	Yes	DWS Offset (in)	1.5
N/A	Shared Landing?	No			
Yes	Gutter Ponding?	No	Yes	Gutter Slope (%)	2.5
Yes	Gutter Lip Ht (in)	0.0	No	Gutter X Slope (%)	4.5
N/A	Painted X Walk1?	No	N/A	Painted X Walk2?	N/A
	X Walk 1 Direction	To NW		X Walk 2 Direction	N/A
	X Walk 1 Width (in)	N/A		X Walk 2 Width (in)	N/A
	X Walk 1 Slope (%)	2.5		X Walk 2 Slope (%)	N/A
	X Walk 1 X Slope (%)	4.4		X Walk 2 X Slope (%)	N/A

N/A	Ramp inside XWalk1?	N/A	N/A	Ramp inside XWalk2?	N/A
	Road Slope (%)	4.4		Clear Space?	Yes
	Road X Slope (%)	2.5	N/A	Clear Space to XWalk (in)	N/A
Yes	Any Obstructions?	No	Yes	Storm Grate/Utility Hazard?	No
	Obstruction Type			Storm Grate/Utility Type	
			N/A		N/A
			Yes	Surface Condition? (G/P)	Good
			Yes	Curb Slope (%)	1.9

Remove & Replace Gutter.

R304.5.3
