Access Compliance Report

Public Rights-of-Way

(Curb Ramps)

Intersection ID: 51371	Main Street: UNIVERSITY_POINTE_BV	Cross Street: N_TRYON_ST	Location: SW
ADA ID: BD9A75B20643	Ramp Type: Perp	Initial Pass/Fail: Fail	Overall Compliance: No
Severity Score: 10			
Codes/Mitigation Info/Possible Solution		Field Measurements/Component Compliance

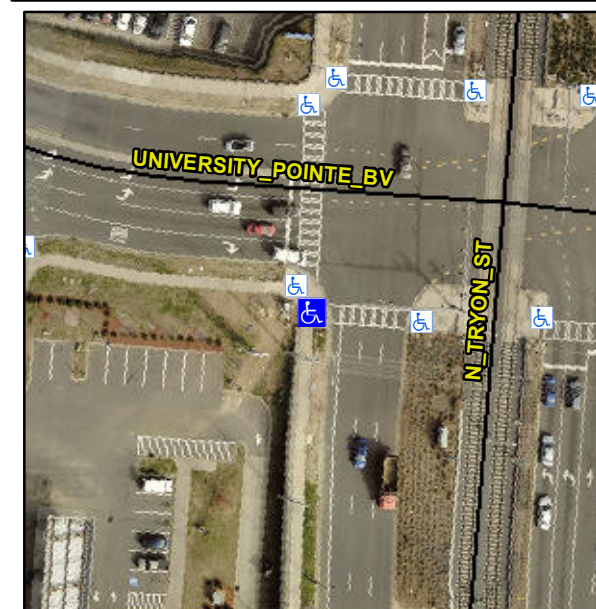
Not Found, R304.5.1, R304.5.3

Compliance	Description	Data	Compliance	Description	Data
N/A	Ramp Length (in)	85.0	Yes	Ramp Slope (%)	6.7
No	Ramp Width (in)	43.5	No	Ramp XSlope (%)	4.7
N/A	Flare Type LT	N/A	N/A	Flare Type RT	N/A
N/A	Flare Slope LT (%)	N/A	N/A	Flare Slope RT (%)	N/A
N/A	Flare Traversable LT?	N/A	N/A	Flare Traversable RT?	N/A
N/A	Landing Length (in)	N/A	N/A	DWS Provided?	N/A
N/A	Landing Width (in)	N/A	N/A	DWS Contrast?	N/A
N/A	Landing Slope (%)	N/A	N/A	DWS Length (in)	N/A
N/A	Landing X Slope (%)	N/A	N/A	DWS Full Width?	N/A
N/A	Landing Curb? (Y/N)	N/A	N/A	DWS Offset (in)	N/A
N/A	Shared Landing?	N/A			
N/A	Gutter Ponding?	N/A	N/A	Gutter Slope (%)	N/A
N/A	Gutter Lip Ht (in)	N/A	N/A	Gutter X Slope (%)	N/A
N/A	Painted X Walk1?	Yes	N/A	Painted X Walk2?	N/A
	X Walk 1 Direction	To E		X Walk 2 Direction	N/A
N/A	X Walk 1 Width (in)	110.0	N/A	X Walk 2 Width (in)	N/A
	X Walk 1 Slope (%)	2.4		X Walk 2 Slope (%)	N/A
	X Walk 1 X Slope (%)	1.4		X Walk 2 X Slope (%)	N/A

N/A	Ramp inside XWalk1?	Yes	N/A	Ramp inside XWalk2?	N/A
	Road Slope (%)	N/A	N/A	Clear Space?	N/A
	Road X Slope (%)	N/A	N/A	Clear Space to XWalk (in)	N/A
N/A	Any Obstructions?	N/A	N/A	Storm Grate/Utility Hazard?	N/A
	Obstruction Type			Storm Grate/Utility Type	
		N/A			N/A
		Yes		Surface Condition? (G/P)	Good

Possible Solutions:

Remove & Replace Entire Ramp.
