## **Access Compliance Report Public Rights-of-Way** (Curb Ramps)

Intersection ID: 4249 Main Street: N\_TRYON\_ST Cross Street: PAVILION\_BV Location: NE Initial Pass/Fail: Fail **Overall Compliance: No** ADA ID: BD9B300A2B41 Ramp Type: Perp **Severity Score:** 0

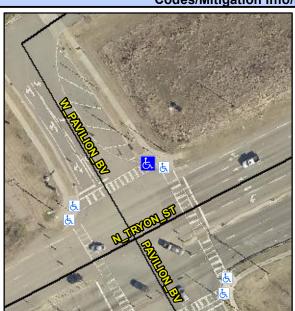
Compliance Description		Data	Comp	liance Description	Data
N/A	Ramp Length (in)	95.0	Yes	Ramp Slope (%)	7.5
Yes	Ramp Width (in)	61.0	Yes	Ramp XSlope (%)	0.4
N/A	Flare Type LT	N/A	N/A	Flare Type RT	N/A
N/A	Flare Slope LT (%)	N/A	N/A	Flare Slope RT (%)	N/A
N/A	Flare Traversable LT?	N/A	N/A	Flare Traversable RT?	N/A
N/A	Landing Length (in)	N/A	N/A	DWS Provided?	N/A
N/A	Landing Width (in)	N/A	N/A	DWS Contrast?	N/A
N/A	Landing Slope (%)	N/A	N/A	DWS Length (in)	N/A
N/A	Landing X Slope (%)	N/A	N/A	DWS Full Width?	N/A
N/A	Landing Curb? (Y/N)	N/A	N/A	DWS Offset (in)	N/A
N/A	Shared Landing?	N/A			
N/A	Gutter Ponding?	N/A	N/A	Gutter Slope (%)	N/A
N/A	Gutter Lip Ht (in)	N/A	N/A	Gutter X Slope (%)	N/A
N/A	Painted X Walk1?	Yes	N/A	Painted X Walk2?	N/A
	X Walk 1 Direction	To SW		X Walk 2 Direction	N/A
N/A	X Walk 1 Width (in)	106.0	N/A	X Walk 2 Width (in)	N/A
	X Walk 1 Slope (%)	0.4		X Walk 2 Slope (%)	N/A
	X Walk 1 X Slope (%)	1.8		X Walk 2 X Slope (%)	N/A

N/A	Ramp inside XWalk1?	Yes	N/A	Ramp inside XWalk2?	N/A
	Road Slope (%)	N/A	N/A	Clear Space?	N/A
	Road X Slope (%)	N/A	N/A	Clear Space to XWalk (in)	N/A
N/A	Any Obstructions?	N/A	N/A	Storm Grate/Utility Hazard?	N/A
	Obstruction Type			Storm Grate/Utility Type	
		N/A			N/A
			Yes	Surface Condition? (G/P)	Good
Mary Mary

200	Possible Solutions:				
1	Remove & Replace Entire Ramp.				
0.00					
A STATE					
	Surveyor Notes:				
	N/A				
-	PROW/ADA:				
S. P.	Not Found				
Salan.					
きる

N/A N/A N/A N/A N/A N/A Total Cost: 1850.00
