Access Compliance Report

Public Rights-of-Way

(Curb Ramps)

Intersection ID: 10123	Main Street: GLENWOOD_DR	Cross Street: TUCKASEEGEE_RD	Location: NE
ADA ID: BDA5329F27C6	Ramp Type: Perp	Initial Pass/Fail: Fail	Overall Compliance: No
Severity Score: 10			
Codes/Mitigation Info/Possible Solution		Field Measurements/Component Compliance

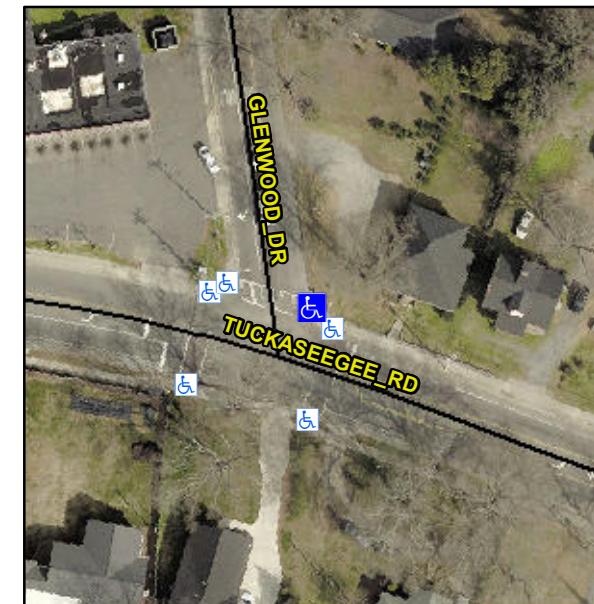
Not Found, R304.5.1

Compliance	Description	Data	Compliance	Description	Data
N/A	Ramp Length (in)	70.0	Yes	Ramp Slope (%)	6.4
No	Ramp Width (in)	47.0	Yes	Ramp XSlope (%)	4.7
N/A	Flare Type LT	N/A	N/A	Flare Type RT	N/A
N/A	Flare Slope LT (%)	N/A	N/A	Flare Slope RT (%)	N/A
N/A	Flare Traversable LT?	N/A	N/A	Flare Traversable RT?	N/A
N/A	Landing Length (in)	N/A	N/A	DWS Provided?	N/A
N/A	Landing Width (in)	N/A	N/A	DWS Contrast?	N/A
N/A	Landing Slope (%)	N/A	N/A	DWS Length (in)	N/A
N/A	Landing X Slope (%)	N/A	N/A	DWS Full Width?	N/A
N/A	Landing Curb? (Y/N)	N/A	N/A	DWS Offset (in)	N/A
N/A	Shared Landing?	N/A			
N/A	Gutter Ponding?	N/A	N/A	Gutter Slope (%)	N/A
N/A	Gutter Lip Ht (in)	N/A	N/A	Gutter X Slope (%)	N/A
N/A	Painted X Walk1?	Yes	N/A	Painted X Walk2?	N/A
	X Walk 1 Direction	To W		X Walk 2 Direction	N/A
N/A	X Walk 1 Width (in)	114.0	N/A	X Walk 2 Width (in)	N/A
	X Walk 1 Slope (%)	4.7		X Walk 2 Slope (%)	N/A
	X Walk 1 X Slope (%)	4.7		X Walk 2 X Slope (%)	N/A

N/A	Ramp inside XWalk1?	Yes	N/A	Ramp inside XWalk2?	N/A
	Road Slope (%)	N/A	N/A	Clear Space?	N/A
	Road X Slope (%)	N/A	N/A	Clear Space to XWalk (in)	N/A
N/A	Any Obstructions?	N/A	N/A	Storm Grate/Utility Hazard?	N/A
	Obstruction Type			Storm Grate/Utility Type	
		N/A			N/A
			Yes	Surface Condition? (G/P)	Good

Possible Solutions:

Remove & Replace Entire Ramp.
