# Access Compliance Report

## Public Rights-of-Way

### (Curb Ramps)

| Intersection ID: 24516 | Main Street: HUNTSCROFT_LN | Cross Street: SADDLEBURY_LN | Location: S |

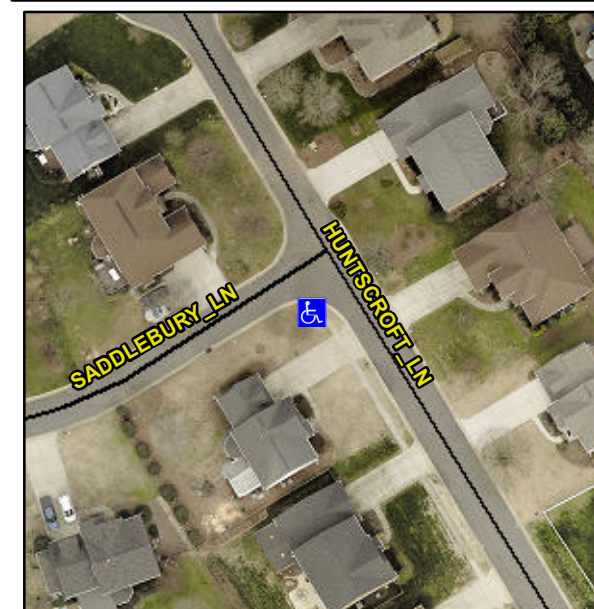
**Not Found, R304.5.1, R304.5.3**

| Compliance | Description | Data | Compliance | Description | Data |
|---|---|---|---|---|---|
| No | Ramp Width (in) | 45.0 | No | BlendTrans XSlope (%) | 5.5 |

**Remove & Replace Curb Ramp With Two New Directional Ramps or Equivalent.**

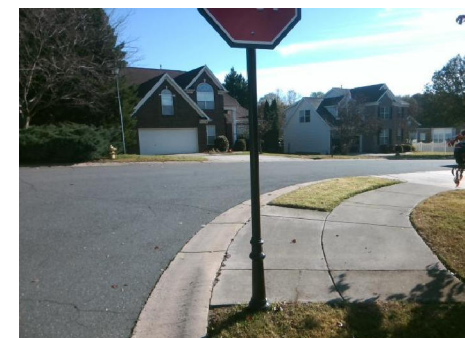
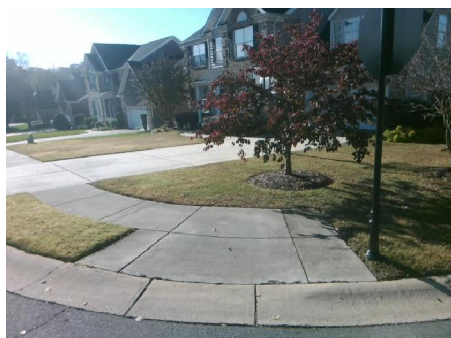
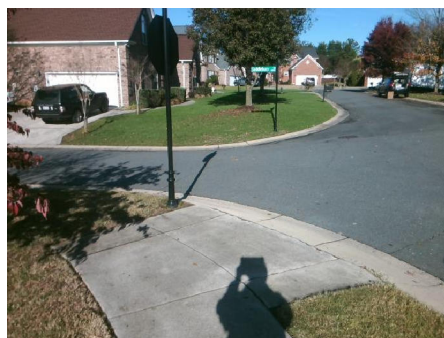
| Compliance | Description | Data | Compliance | Description | Data |
|---|---|---|---|---|---|
| | | | No | Curb Slope (%) | 7.9 |
