Access Compliance Report

Public Rights-of-Way

(Curb Ramps)

Intersection ID: 10001	Main Street: OAKLAWN_AV	Cross Street: STROUD_PARK_CT	Location: NE
ADA ID: BDB35B39581C	Ramp Type: ParaDiag	Initial Pass/Fail: Fail	Overall Compliance: No
			Severity Score: 26.25

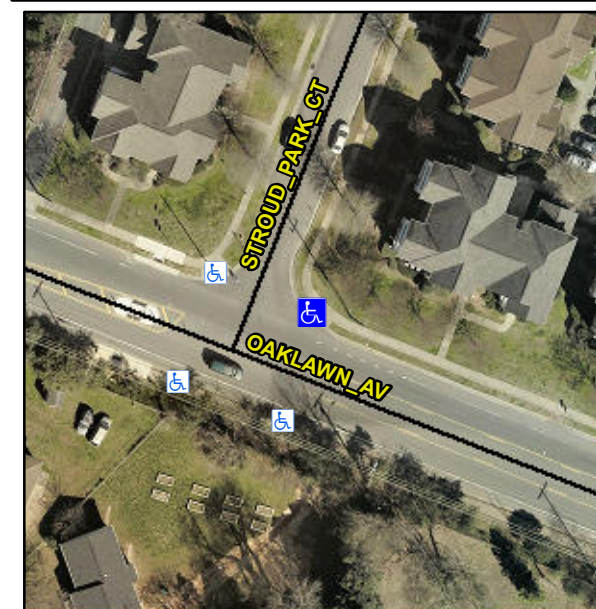
LT RP < 5%

R304.5.3, R304.3.2

Compliance	Description	Data	Compliance	Description	Data
N/A	Ramp Length LT (in)	50.0	N/A	Ramp Length RT (in)	52.0
Yes	Ramp Width LT (in)	59.5	Yes	Ramp Width RT (in)	59.5
Yes	Ramp Slope LT (%)	4.6	No	Ramp Slope RT (%)	12.4
No	Ramp XSlope LT (%)	2.5	Yes	Ramp XSlope RT (%)	1.2
N/A	Landing Length (in)	N/A	N/A	DWS Provided?	N/A
N/A	Landing Width (in)	N/A	N/A	DWS Contrast?	N/A
N/A	Landing Slope (%)	N/A	N/A	DWS Length (in)	N/A
N/A	Landing X Slope (%)	N/A	N/A	DWS Full Width?	N/A
N/A	Landing Curb? (Y/N)	N/A	N/A	DWS Offset (in)	N/A
N/A	Shared Landing?	N/A			
N/A	Gutter Ponding?	N/A	N/A	Gutter Slope (%)	N/A
N/A	Gutter Lip Ht (in)	N/A	N/A	Gutter X Slope (%)	N/A
N/A	Painted X Walk1?	No	N/A	Painted X Walk2?	No
	X Walk 1 Direction	To W		X Walk 2 Direction	To S
N/A	X Walk 1 Width (in)	N/A	N/A	X Walk 2 Width (in)	N/A
	X Walk 1 Slope (%)	2.6		X Walk 2 Slope (%)	2.1
	X Walk 1 X Slope (%)	3.1		X Walk 2 X Slope (%)	2.5
N/A	Ramp inside XWalk1?	N/A	N/A	Ramp inside XWalk2?	N/A

Road Slope (%)	3.5	N/A	Clear Space?	N/A
	Road X Slope (%)	2.8	N/A	Clear Space to XWalk (in)	N/A
N/A	Any Obstructions?	N/A	N/A	Storm Grate/Utility Hazard?	N/A
	Obstruction Type			Storm Grate/Utility Type	
		N/A			N/A
			Yes	Surface Condition? (G/P)	Good
			N/A	Curb Slope (%)	N/A

Possible Solutions:

Remove & Replace Curb Ramp With Two New Directional Ramps or Equivalent.
