Access Compliance Report

Public Rights-of-Way

(Curb Ramps)

Intersection ID: 24855	Main Street: MACANDREW_DR	Cross Street: TWYNHAM_LN	Location:	N
ADA ID: BDB650EB16BF	Ramp Type: PerpDiag	Initial Pass/Fail: Fail	Overall Compliance: No	Severity Score: 12.5

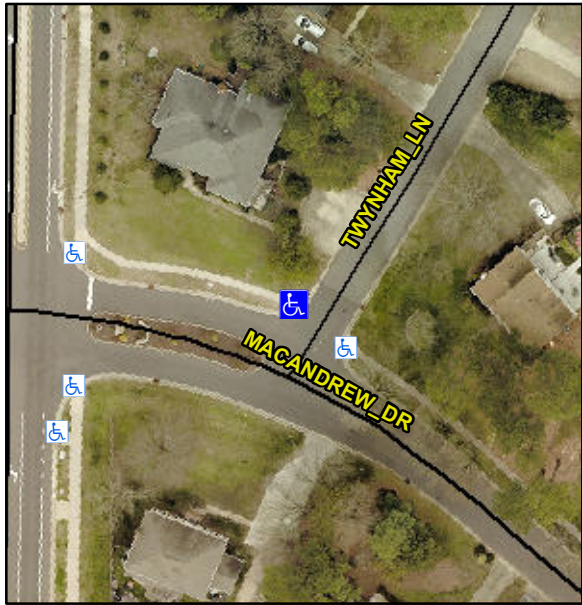
Possible Solutions:		Compliance	Description	Data	Compliance	Description	Data
	Remove & Replace Curb Ramp With Two New Directional Ramps or Equivalent.		N/A	Ramp Length (in)	57.0	Yes	Ramp Slope (%)	6.5
			Yes	Ramp Width (in)	48.0	No	Ramp XSlope (%)	6.1
			N/A	Flare Type LT	N/A	N/A	Flare Type RT	N/A
			N/A	Flare Slope LT (%)	N/A	N/A	Flare Slope RT (%)	N/A
			N/A	Flare Traversable LT?	N/A	N/A	Flare Traversable RT?	N/A
			N/A	Landing Length (in)	N/A	N/A	DWS Provided?	N/A
			N/A	Landing Width (in)	N/A	N/A	DWS Contrast?	N/A
			N/A	Landing Slope (%)	N/A	N/A	DWS Length (in)	N/A
			N/A	Landing X Slope (%)	N/A	N/A	DWS Full Width?	N/A
Surveyor Notes:		N/A	N/A	Landing Curb? (Y/N)	N/A	N/A	DWS Offset (in)	N/A
PROW/ADA:		Not Found, R304.5.3	N/A	Shared Landing?	N/A			
			N/A	Gutter Ponding?	N/A	N/A	Gutter Slope (%)	N/A
			N/A	Gutter Lip Ht (in)	N/A	N/A	Gutter X Slope (%)	N/A
