Access Compliance Report

Public Rights-of-Way

(Curb Ramps)

Intersection ID: 3062	Main Street: LOGANVILLE_DR	Cross Street: BENFIELD_RD	Location: W
ADA ID: BDB758FC8338	Ramp Type: Perp	Initial Pass/Fail: Fail	Overall Compliance: No
Codes/Mitigation Info/Possible Solution		Field Measurements/Component Compliance	
Severity Score: 33.75

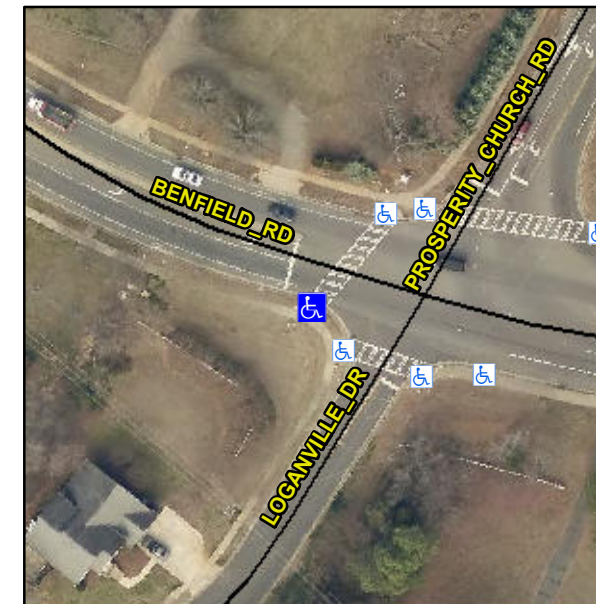
R304.5.1, R304.2.2

Compliance	Description	Data	Compliance	Description	Data
N/A	Ramp Length (in)	73.0	No	Ramp Slope (%)	20.0
No	Ramp Width (in)	36.5	Yes	Ramp XSlope (%)	1.4
N/A	Flare Type LT	N/A	N/A	Flare Type RT	N/A
N/A	Flare Slope LT (%)	N/A	N/A	Flare Slope RT (%)	N/A
N/A	Flare Traversable LT?	N/A	N/A	Flare Traversable RT?	N/A
N/A	Landing Length (in)	N/A	N/A	DWS Provided?	N/A
N/A	Landing Width (in)	N/A	N/A	DWS Contrast?	N/A
N/A	Landing Slope (%)	N/A	N/A	DWS Length (in)	N/A
N/A	Landing X Slope (%)	N/A	N/A	DWS Full Width?	N/A
N/A	Landing Curb? (Y/N)	N/A	N/A	DWS Offset (in)	N/A
N/A	Shared Landing?	N/A			
N/A	Gutter Ponding?	N/A	N/A	Gutter Slope (%)	N/A
N/A	Gutter Lip Ht (in)	N/A	N/A	Gutter X Slope (%)	N/A
N/A	Painted X Walk1?	Yes	N/A	Painted X Walk2?	N/A
	X Walk 1 Direction	To NE		X Walk 2 Direction	N/A
N/A	X Walk 1 Width (in)	108.0	N/A	X Walk 2 Width (in)	N/A
	X Walk 1 Slope (%)	0.9		X Walk 2 Slope (%)	N/A
	X Walk 1 X Slope (%)	0.9		X Walk 2 X Slope (%)	N/A

N/A	Ramp inside XWalk1?	Yes	N/A	Ramp inside XWalk2?	N/A
	Road Slope (%)	N/A	N/A	Clear Space?	N/A
	Road X Slope (%)	N/A	N/A	Clear Space to XWalk (in)	N/A
N/A	Any Obstructions?	N/A	N/A	Storm Grate/Utility Hazard?	N/A
	Obstruction Type			Storm Grate/Utility Type	
		N/A			N/A
			Yes	Surface Condition? (G/P)	Good

Possible Solutions:

Remove & Replace Entire Ramp.

Total Cost: \$ 1850.00
