Access Compliance Report

Public Rights-of-Way

(Curb Ramps)

| Intersection ID: 14873 | Main Street: BRIAR_CREEK_RD | Cross Street: E_INDEPENDENCE/BRIAR_CREEK_RA | Location: NE |

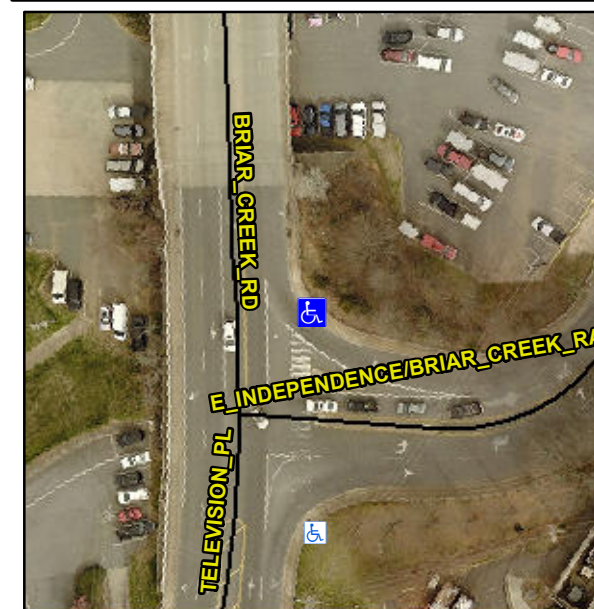
Not Found, R304.5.1, R304.2.2

| Compliance | Description | Data | Compliance | Description | Data |
|---|---|---|---|---|---|
| N/A | Ramp Length (in) | 48.0 | No | Ramp Slope (%) | 9.0 |
| No | Ramp Width (in) | 45.0 | Yes | Ramp XSlope (%) | 0.7 |

Remove & Replace Curb Ramp With Two New Directional Ramps or Equivalent.
