Intersection ID: 29164	Main Street: GARRISON_RD	Cross Street: PURPLE_BLOOM_LN	Location:	E
ADA ID: BDCC743863BA	Ramp Type: BlendTrans1	Initial Pass/Fail: Fail	Overall Compliance: No	Severity Score: 8.75

Street 1 Name	GARRISON RD
Stop Condition-Street 1	StopSign
Street 2 Name	PURPLE BLOOM LN
Stop Condition-Street 2	None

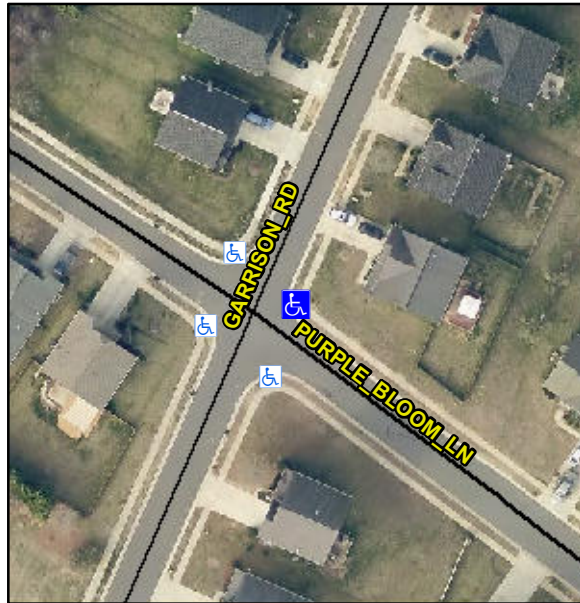
Not Found, R304.5.1

Compliance	Description	Data	Compliance	Description	Data
N/A	Ramp Length (in)	49.0	Yes	BlendTrans Slope (%)	2.6
No	Ramp Width (in)	39.5	Yes	BlendTrans XSlope (%)	1.0
N/A	Flare Type LT	N/A	N/A	Flare Type RT	N/A
N/A	Flare Slope LT (%)	N/A	N/A	Flare Slope RT (%)	N/A
N/A	Flare Traversable LT?	N/A	N/A	Flare Traversable RT?	N/A
N/A	Landing Length (in)	N/A	N/A	DWS Provided?	N/A
N/A	Landing Width (in)	N/A	N/A	DWS Contrast?	N/A
N/A	Landing Slope (%)	N/A	N/A	DWS Length (in)	N/A
N/A	Landing X Slope (%)	N/A	N/A	DWS Full Width?	N/A
N/A	Landing Curb? (Y/N)	N/A	N/A	DWS Offset (in)	N/A
N/A	Shared Landing?	N/A			
N/A	Gutter Ponding?	N/A	N/A	Gutter Slope (%)	N/A
N/A	Gutter Lip Ht (in)	N/A	N/A	Gutter X Slope (%)	N/A
N/A	Painted X Walk1?	No	N/A	Painted X Walk2?	No
	X Walk 1 Direction	To NW		X Walk 2 Direction	To SW
	X Walk 1 Width (in)	N/A		X Walk 2 Width (in)	N/A
	X Walk 1 Slope (%)	4.9		X Walk 2 Slope (%)	5.5
	X Walk 1 X Slope (%)	5.9		X Walk 2 X Slope (%)	5.2

N/A	Ramp inside XWalk1?	N/A	N/A	Ramp inside XWalk2?	N/A
	Road Slope (%)	4.3		Clear Space?	N/A
	Road X Slope (%)	7.5	N/A	Clear Space to XWalk (in)	N/A
N/A	Any Obstructions?	N/A	N/A	Storm Grate/Utility Hazard?	N/A
	Obstruction Type			Storm Grate/Utility Type	
		N/A			N/A
			Yes	Surface Condition? (G/P)	Good
			No	Curb Slope (%)	9.4

Remove & Replace Curb Ramp With Two New Directional Ramps or Equivalent.
