# Access Compliance Report

## Public Rights-of-Way

### (Curb Ramps)

| Intersection ID: 14095 | Main Street: CAMDEN_RD | Cross Street: W_WORTHINGTON_AV | Location: N |

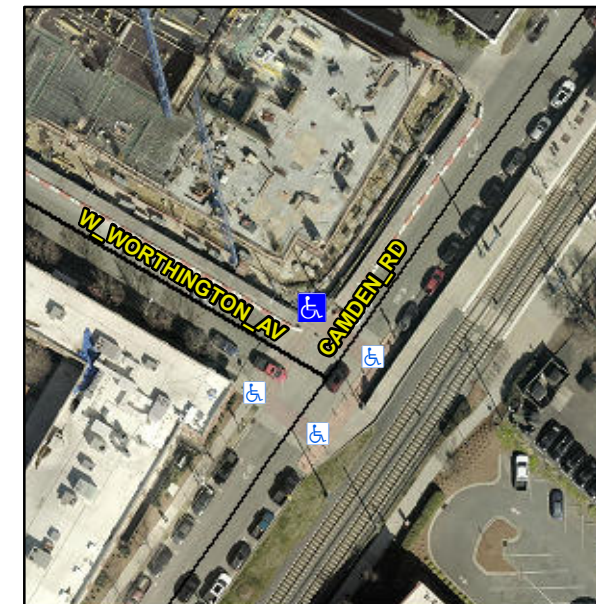
| ADA ID: BDD80EE05ACE | Ramp Type: BlendTrans1 | Initial Pass/Fail: Fail | Overall Compliance: No |
| | | | Severity Score: 35 |

| Compliance | Description | Data | Compliance | Description | Data |
|---|---|---|---|---|---|
| No | Ramp Width (in) | 25.0 | Yes | BlendTrans XSlope (%) | 0.6 |

**Remove & Replace Curb Ramp With Two New Directional Ramps or Equivalent.**

**R304.5.1**

Total Cost: \$ 3200.00
