Access Compliance Report Public Rights-of-Way (Curb Ramps)

Intersection ID: 47574 Main Street: BARRANDS LN **Cross Street: GAILES DR** Location: SW Initial Pass/Fail: Fail **Overall Compliance: No ADA ID: BDE2414F814F** Ramp Type: PerpDiag Severity Score: 13.75

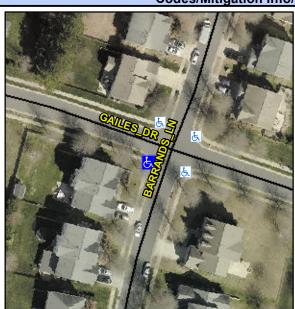
Possible Solutions: Remove & Replace Curb Ramp With Two New Directional Ramps or Equivalent. Surveyor Notes: N/A PROW/ADA: Not Found, R304.2.2, R304.5.3
